# Timber structures

## Case studies

PIETRO CROCE

Assessment of existing structures

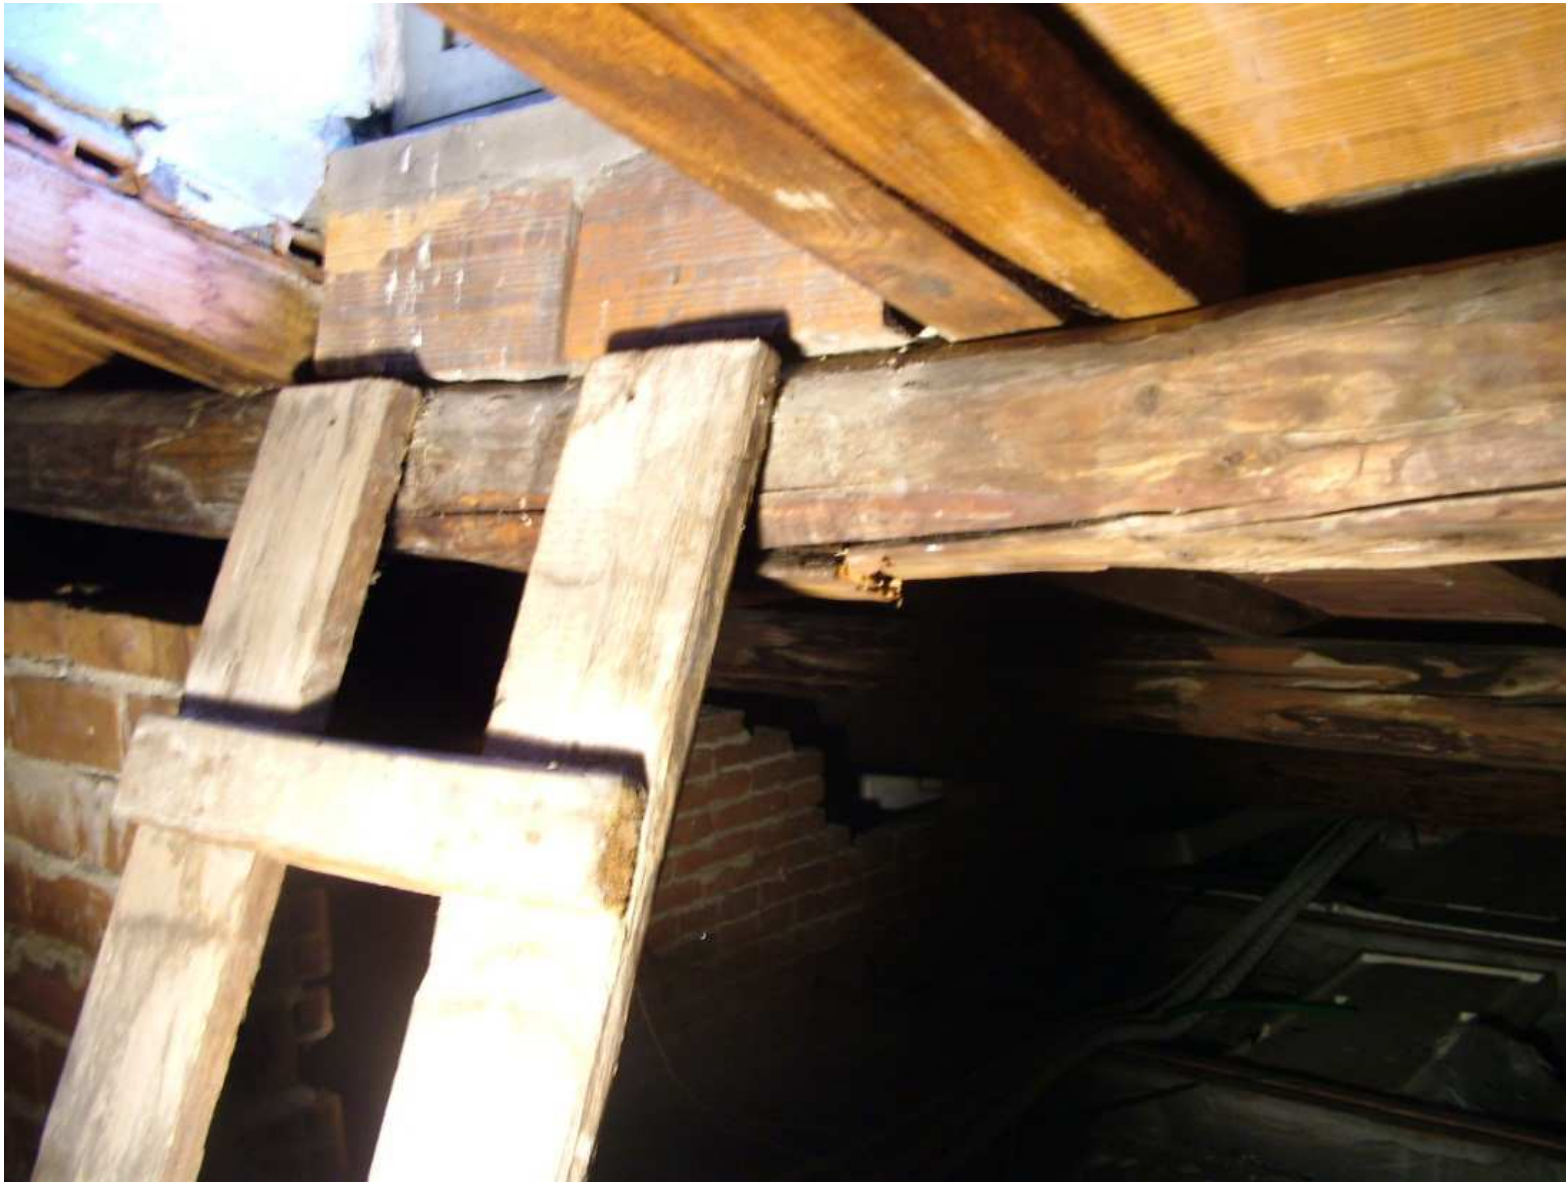
Cracked beam

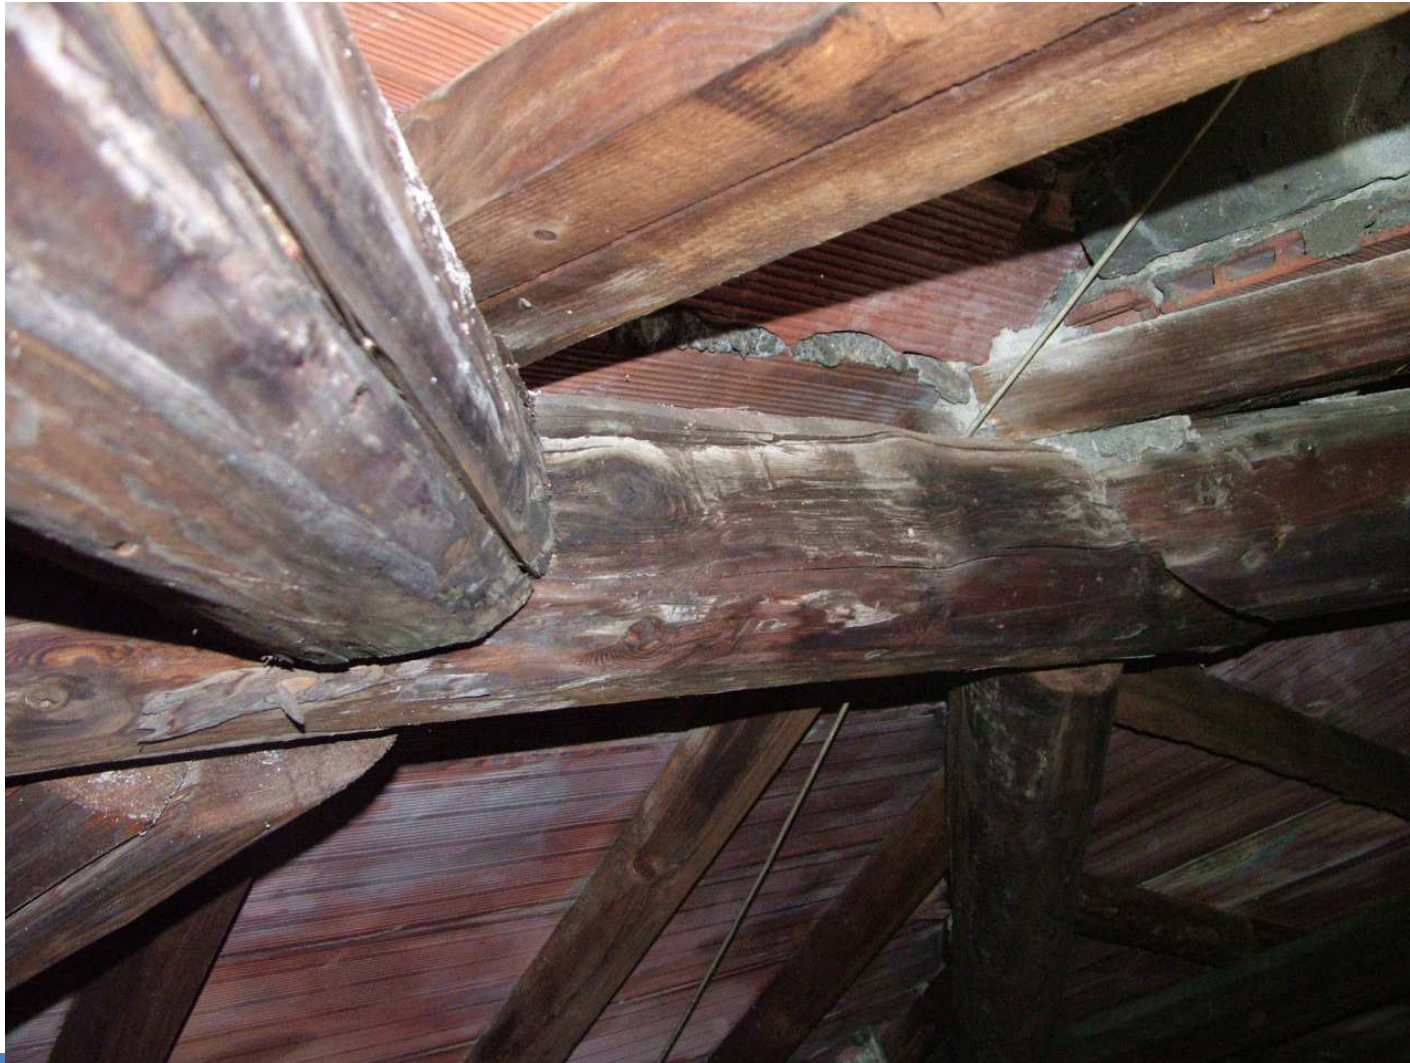
**Cracked beam**

**Damaged columns**

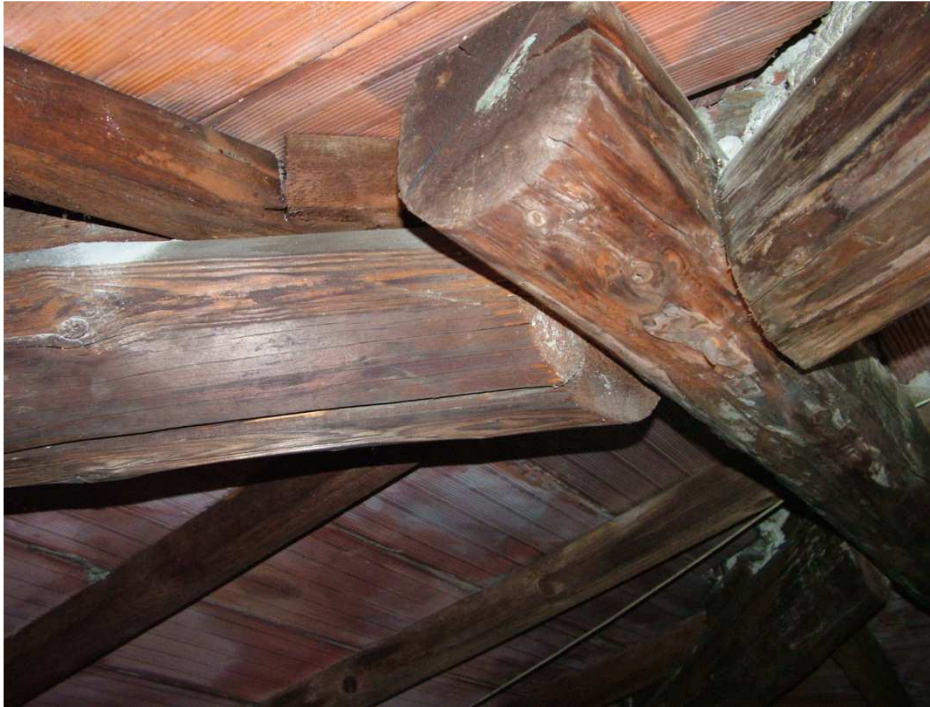
Damaged columns

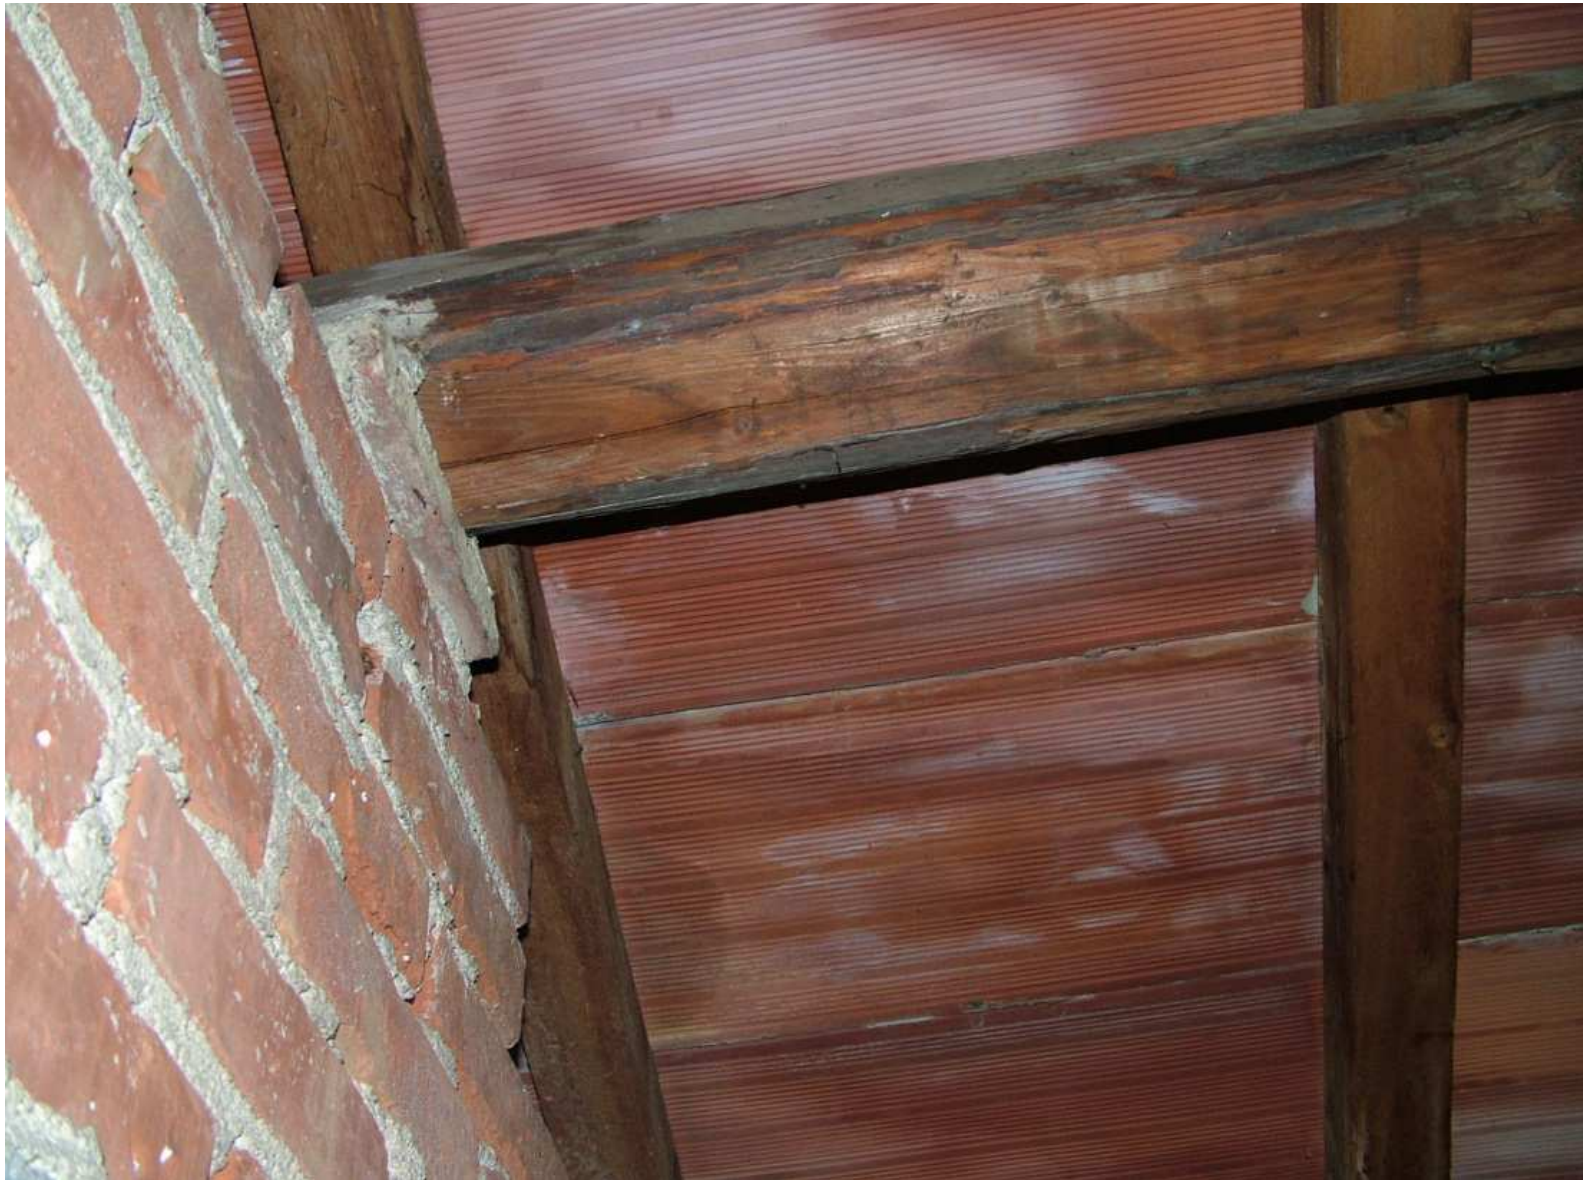
Crack pattern in a beam

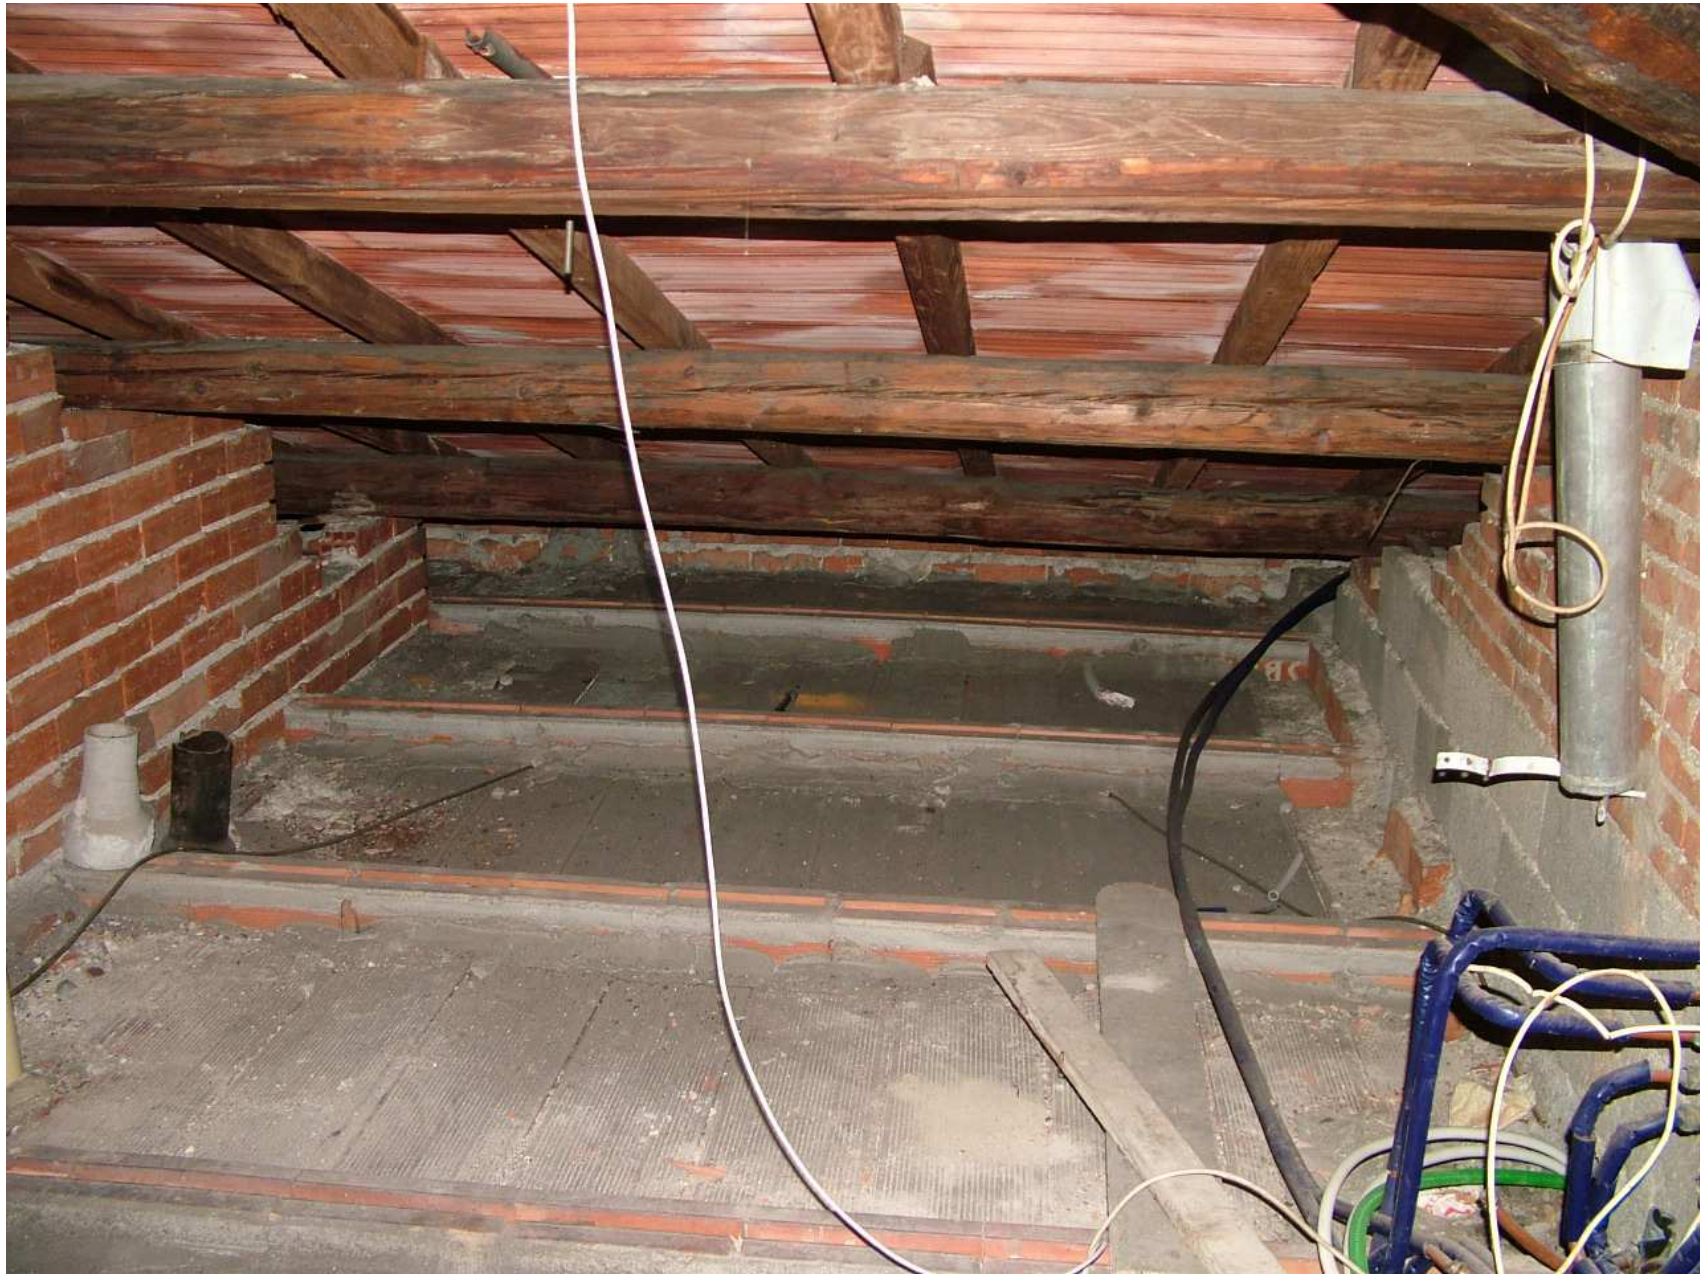
Cracked beam

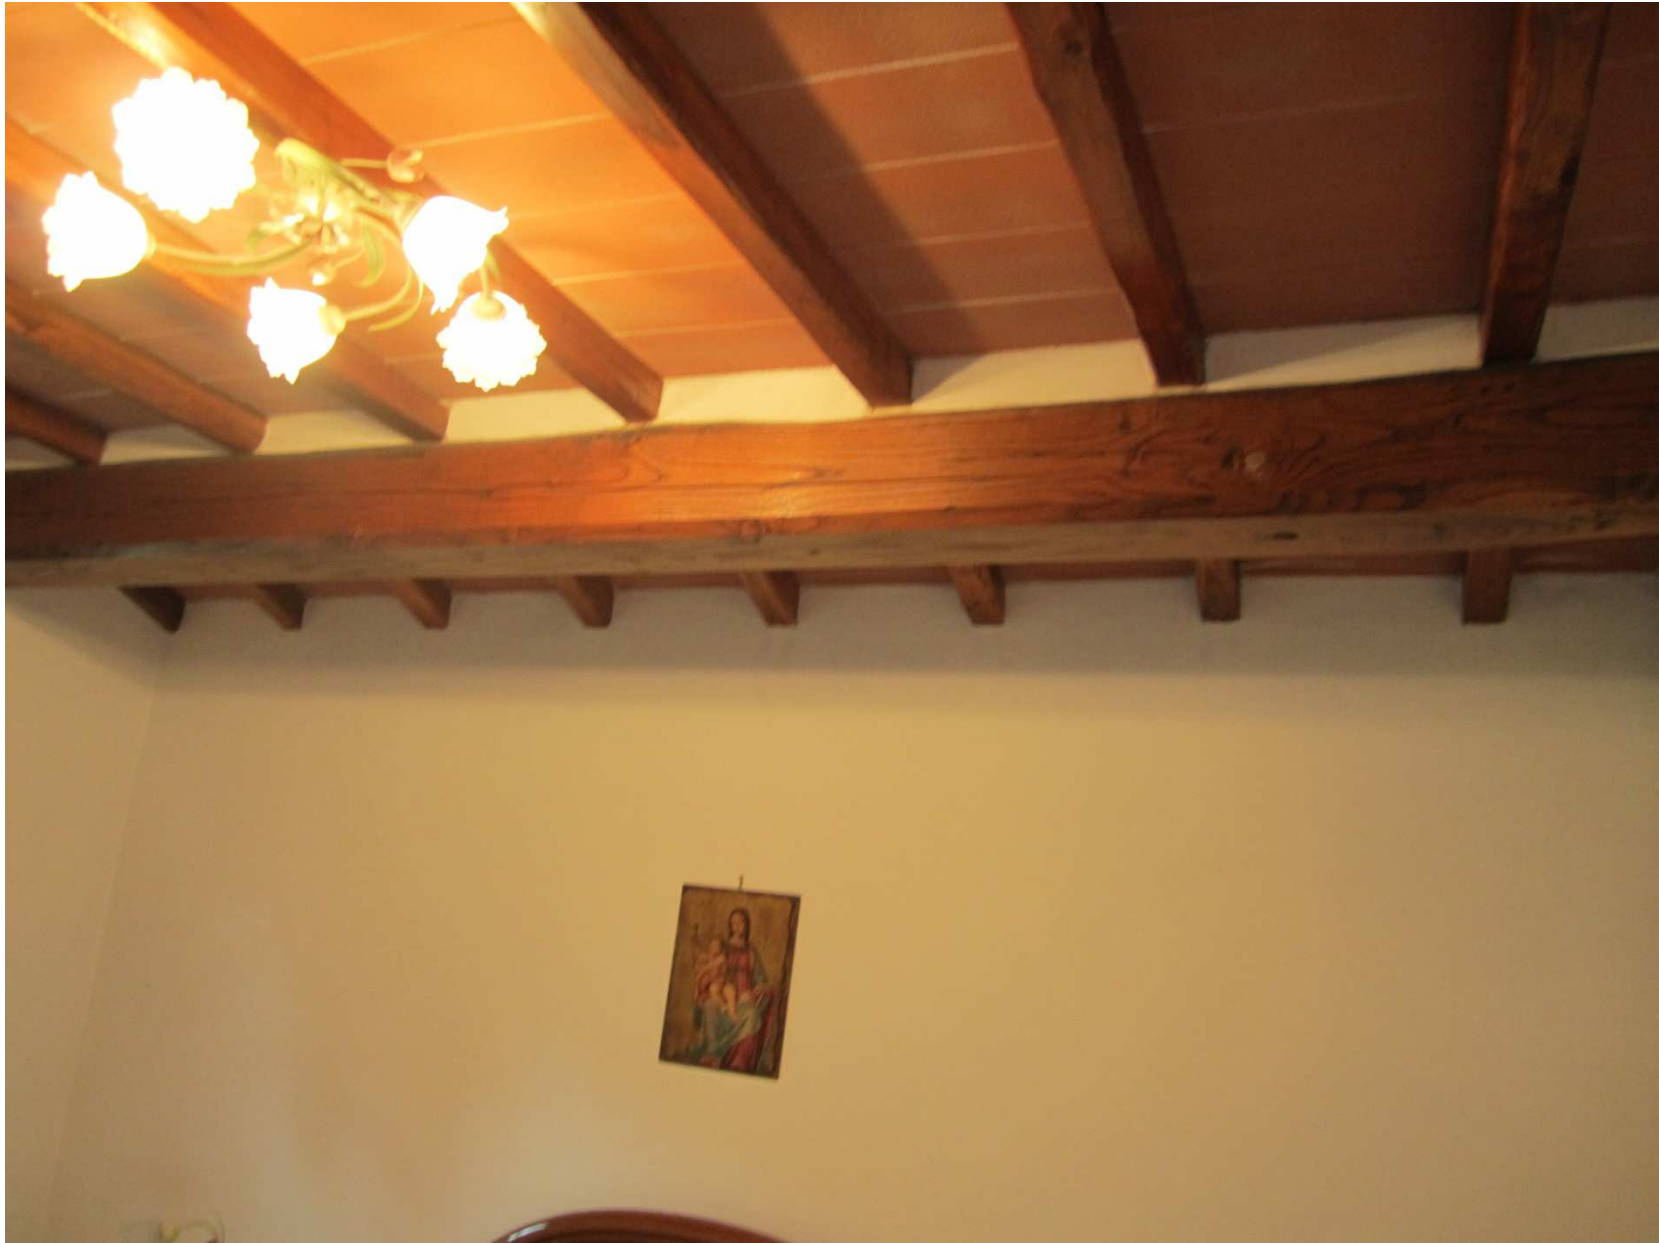
**Insufficient cross section – Uncorrect wood fibre pattern**

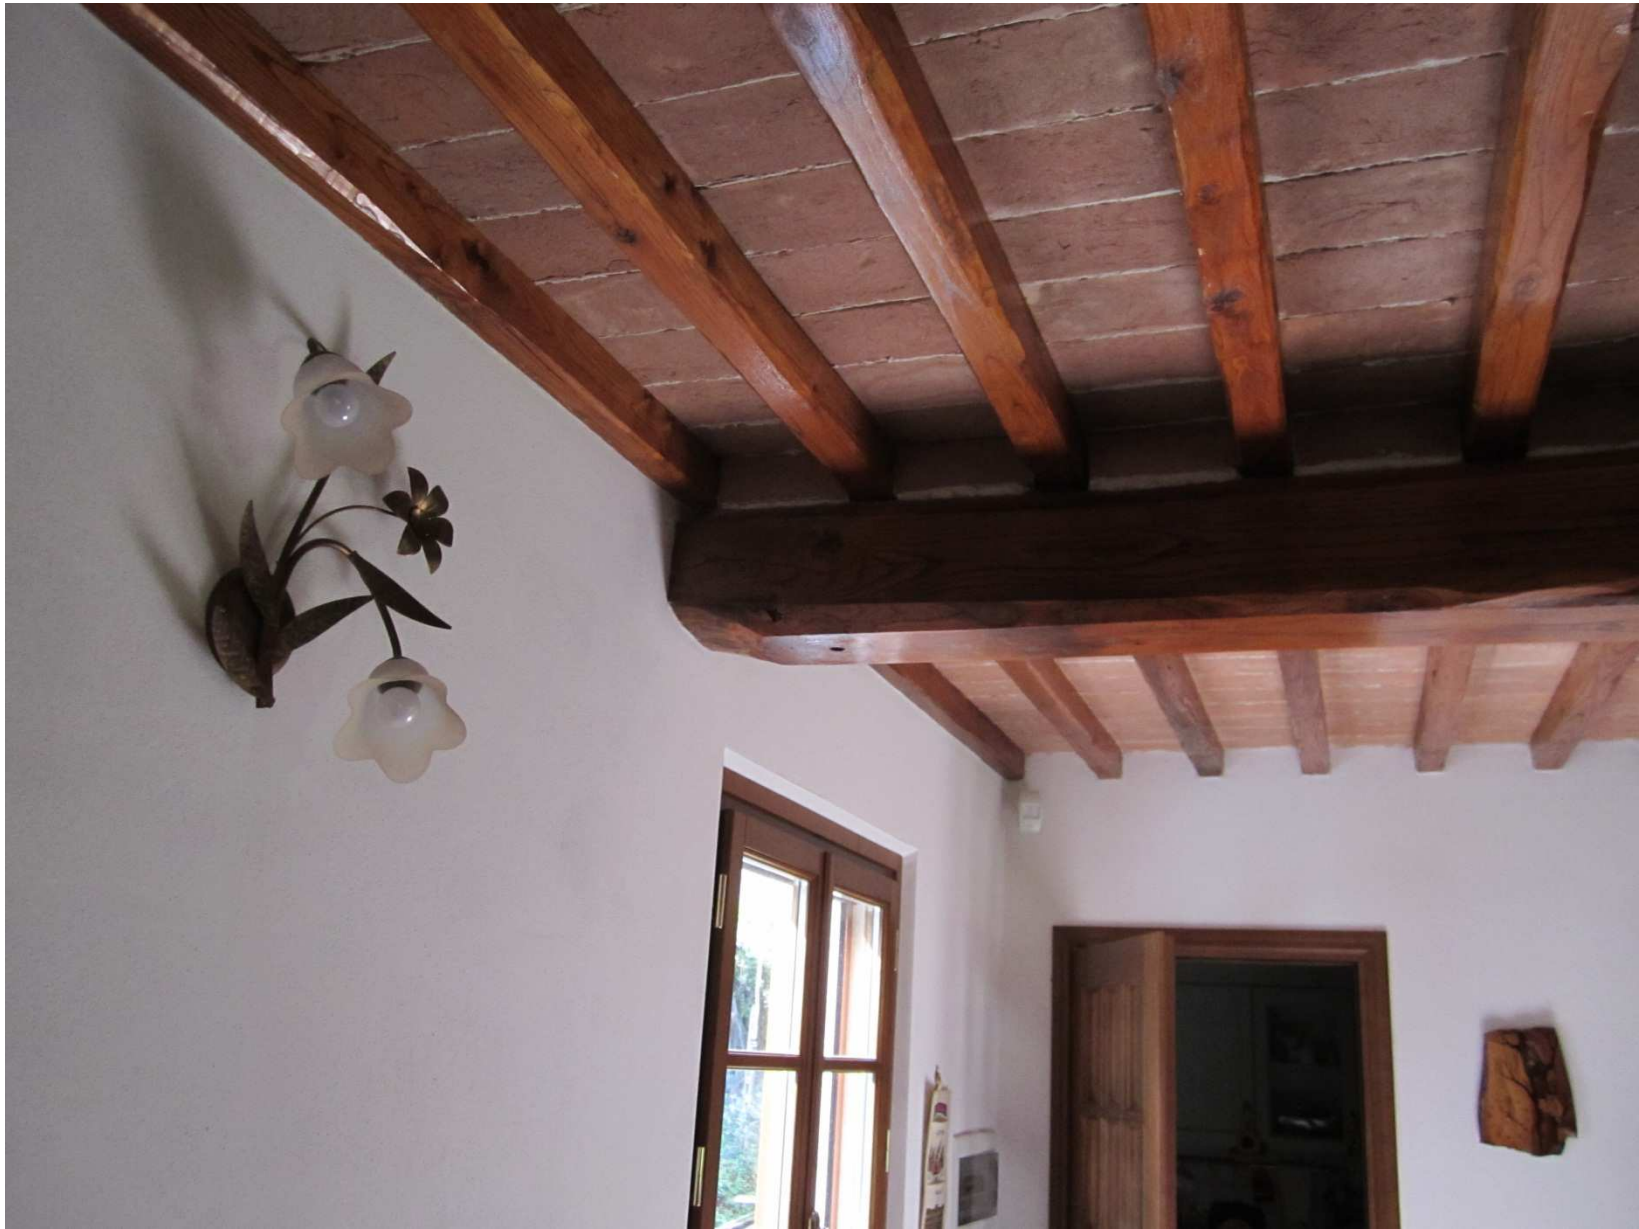
**Insufficient cross section – Uncorrect wood fibre pattern**

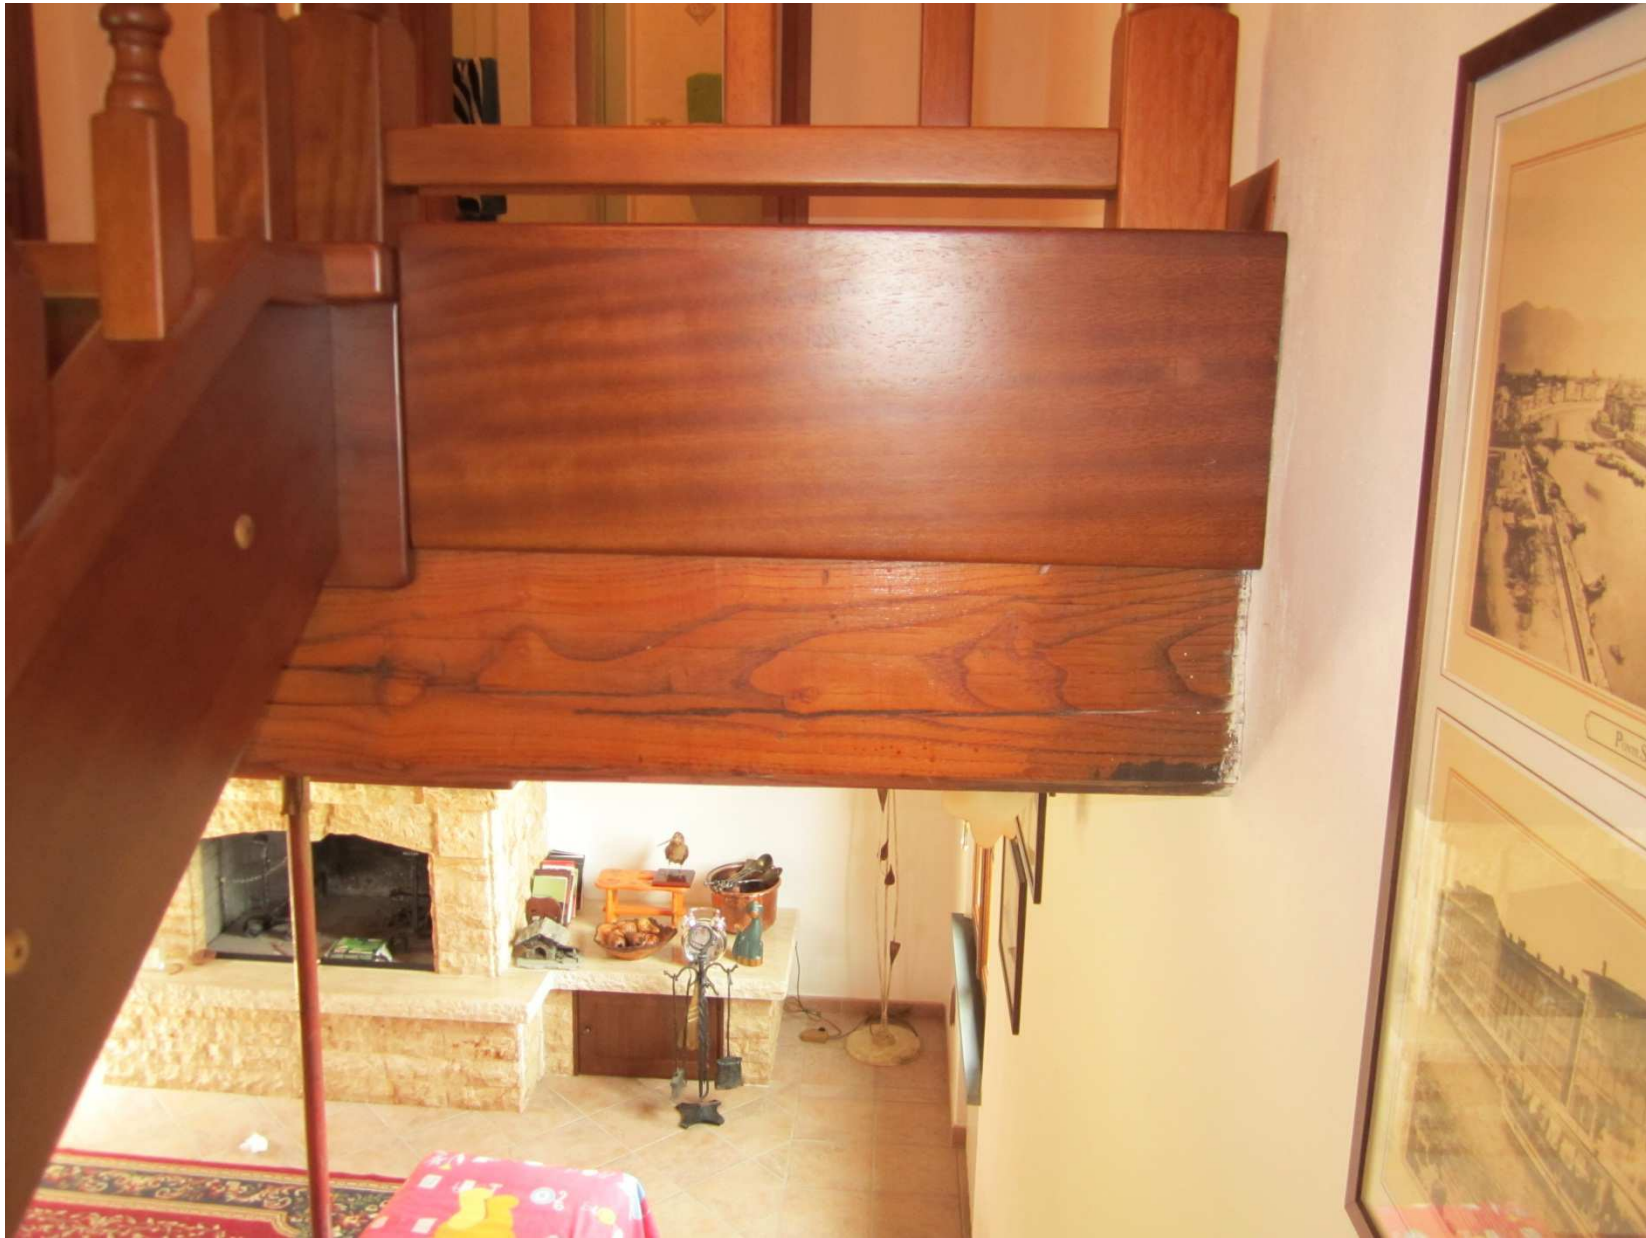
**Insufficient cross section – Uncorrect wood fibre pattern**

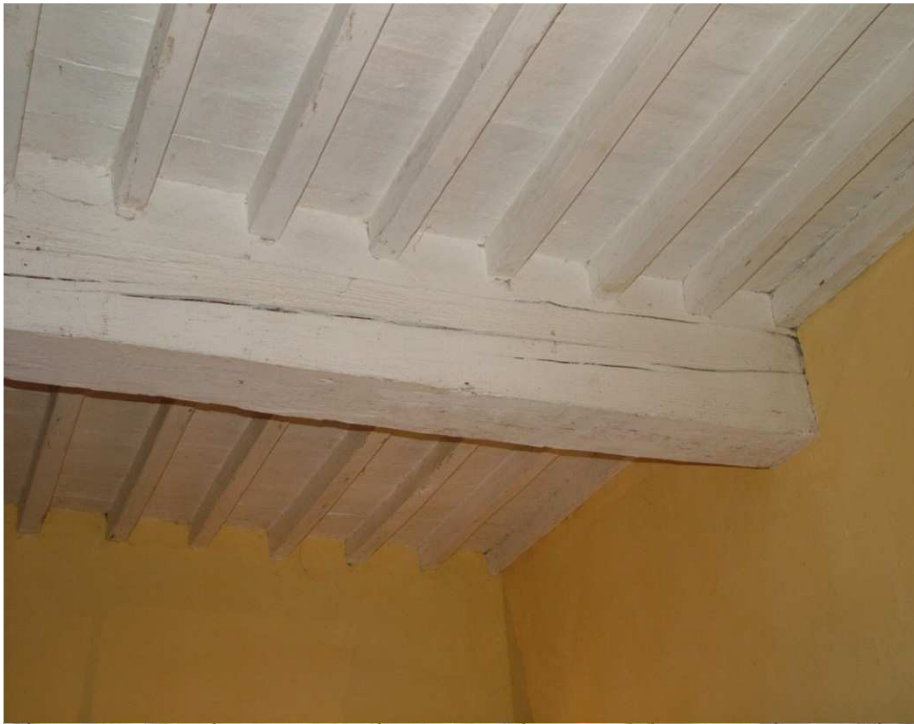
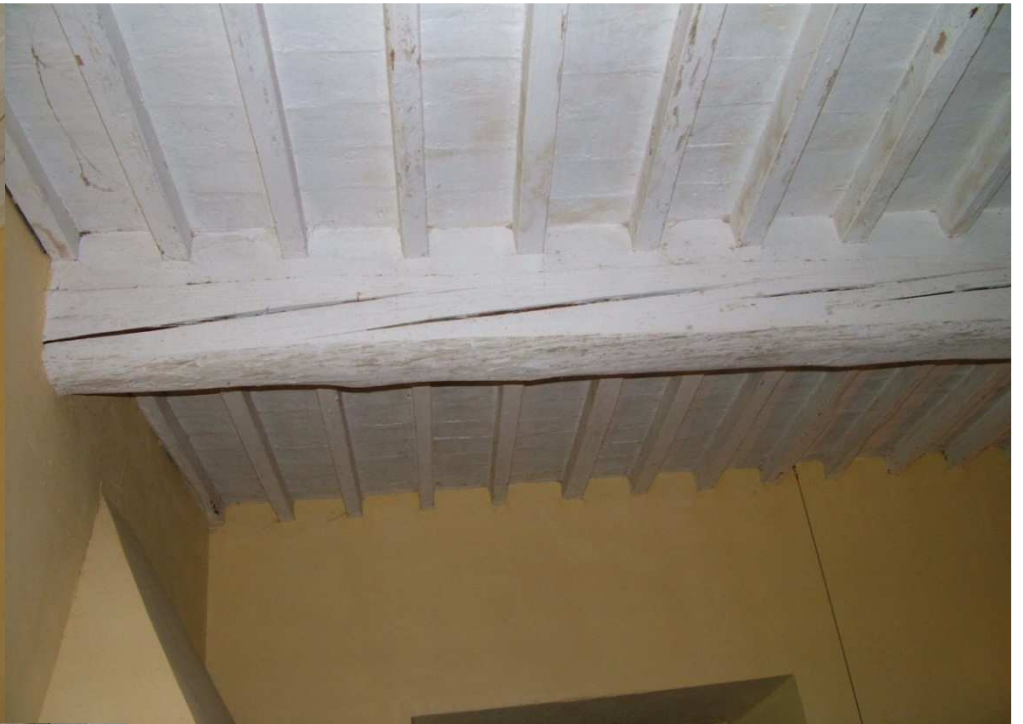
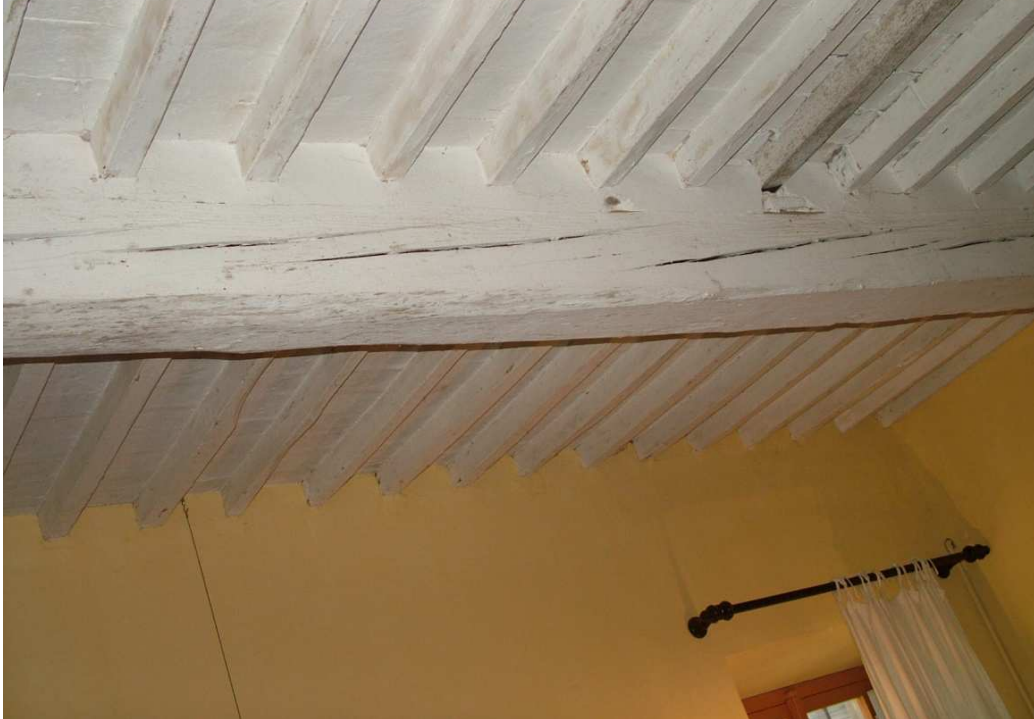
**Typical crack pattern**

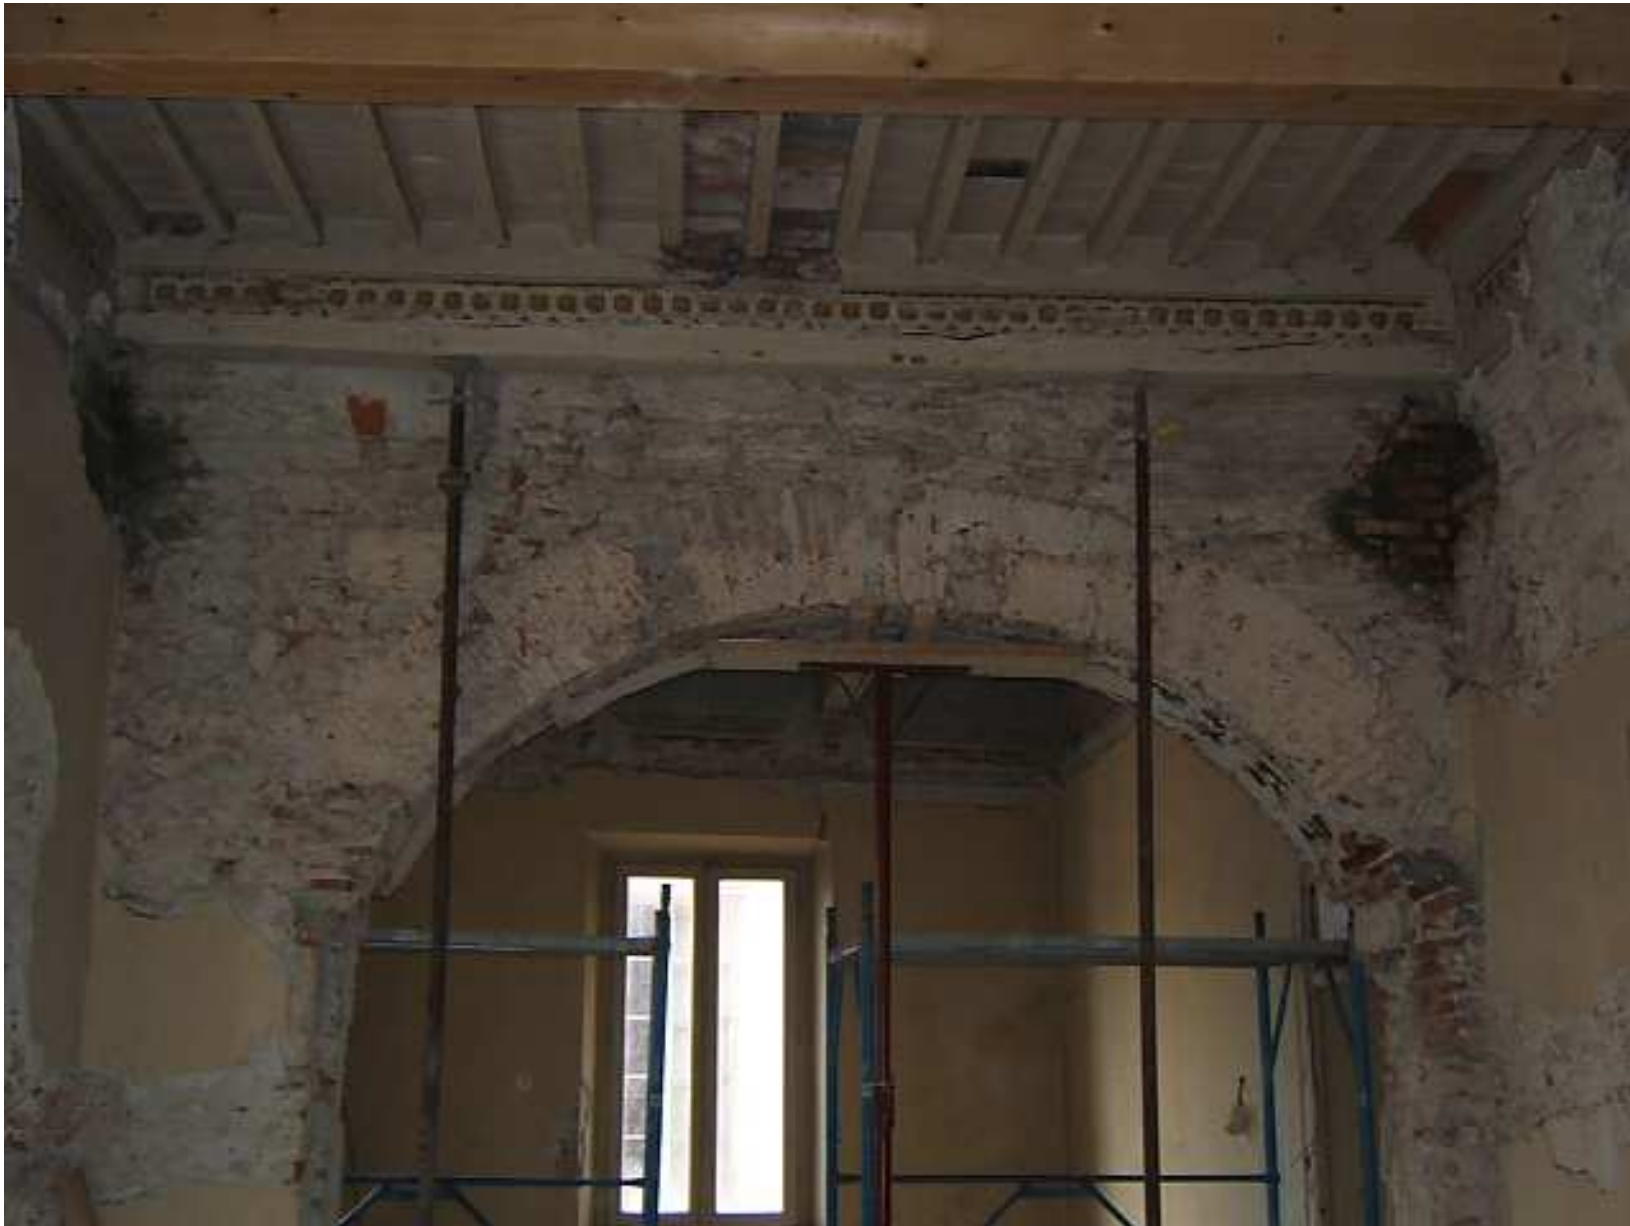
**Arch to be strengthened**
