Concrete and timber structures

Case studies

PIETRO CROCE

Assessment of existing structures

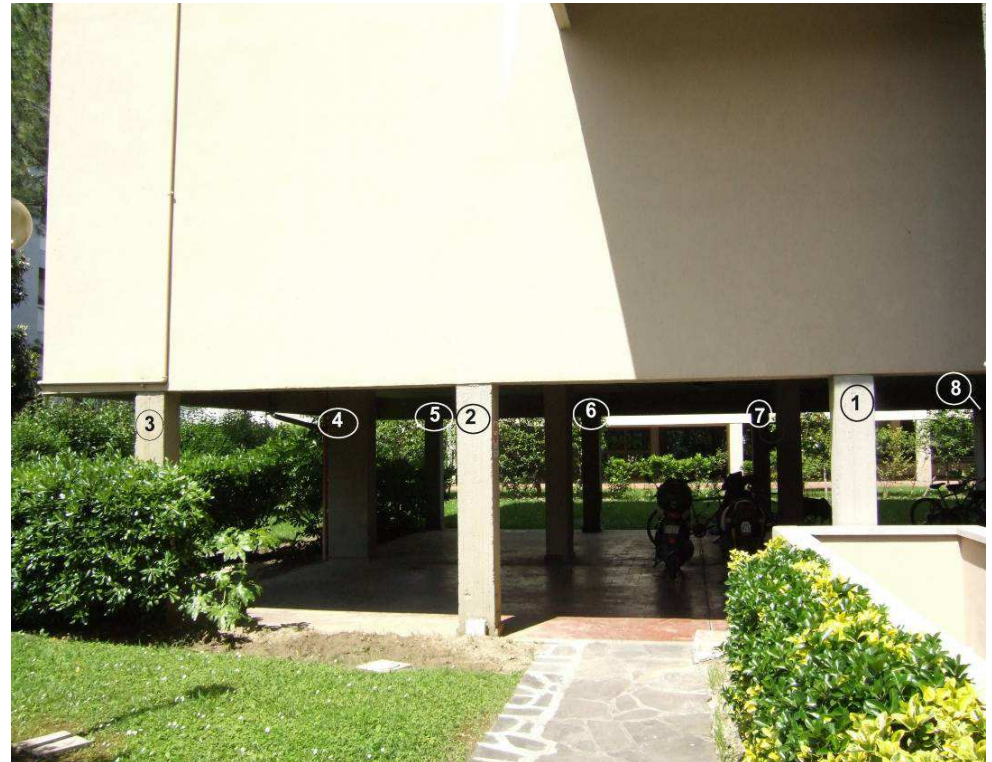
Damaged columns

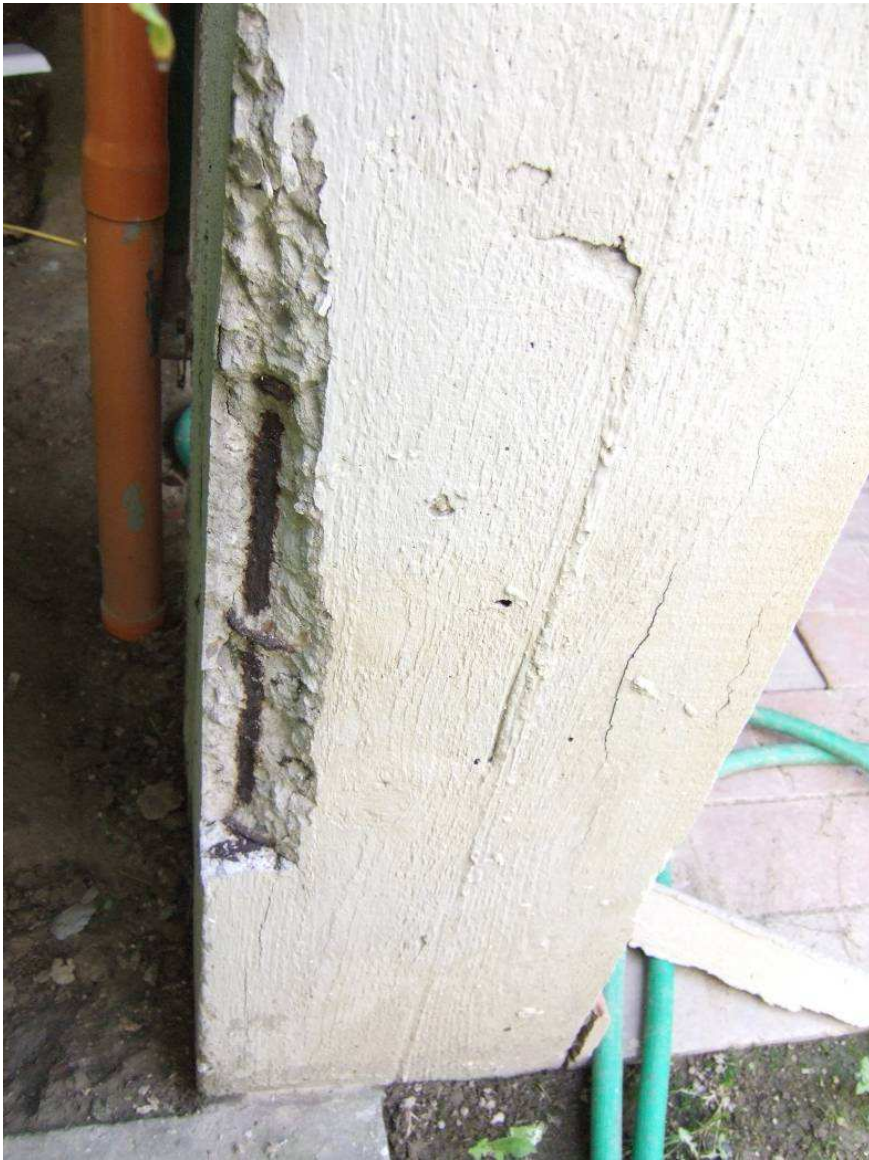
Corroded rebars

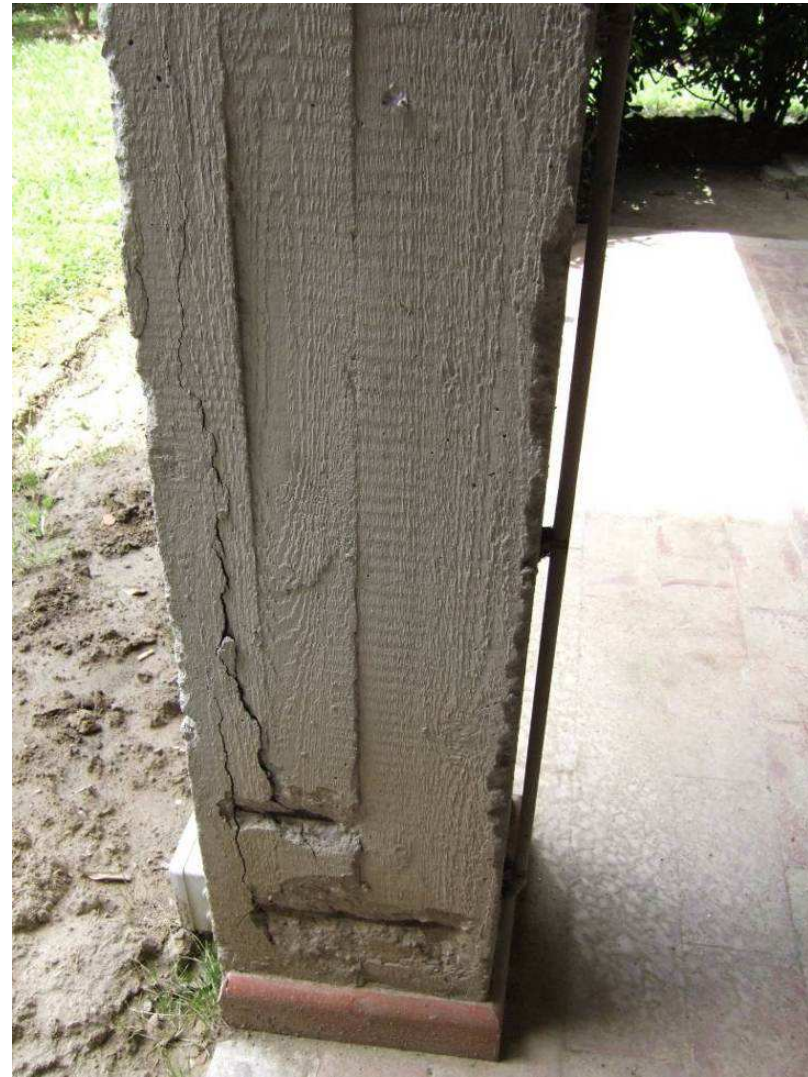
**Cracking of concrete
cover**

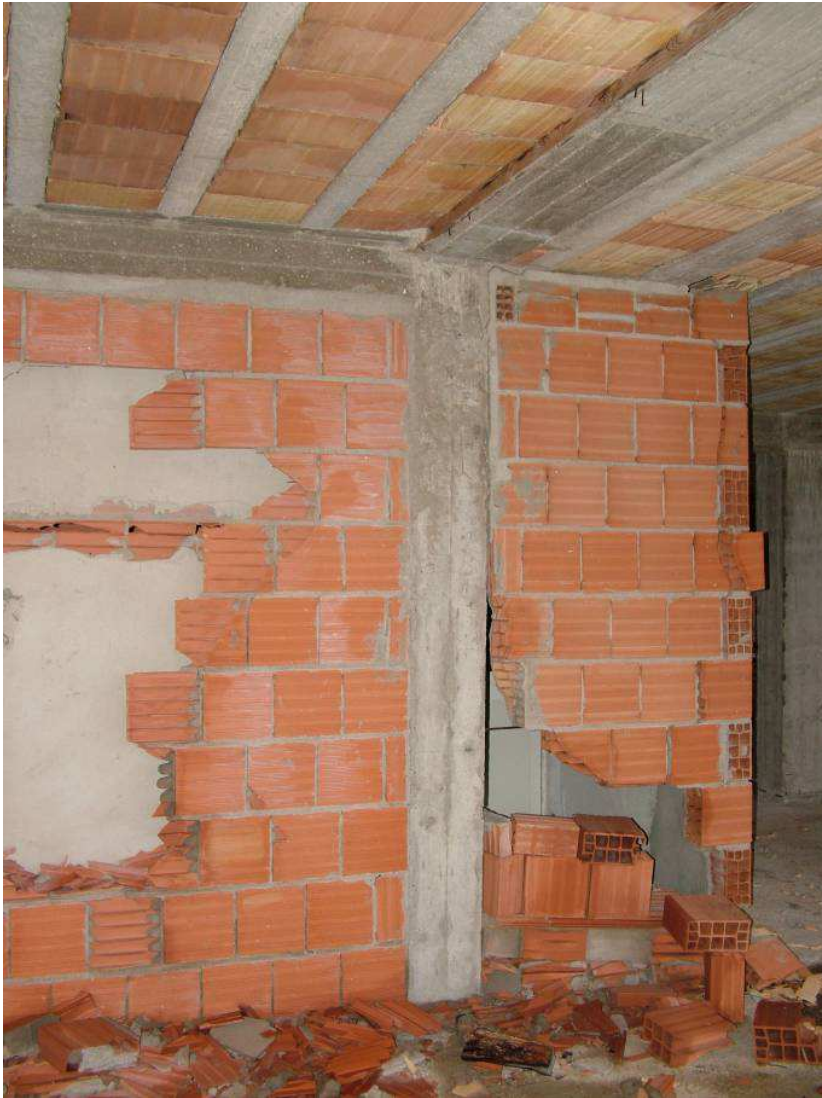
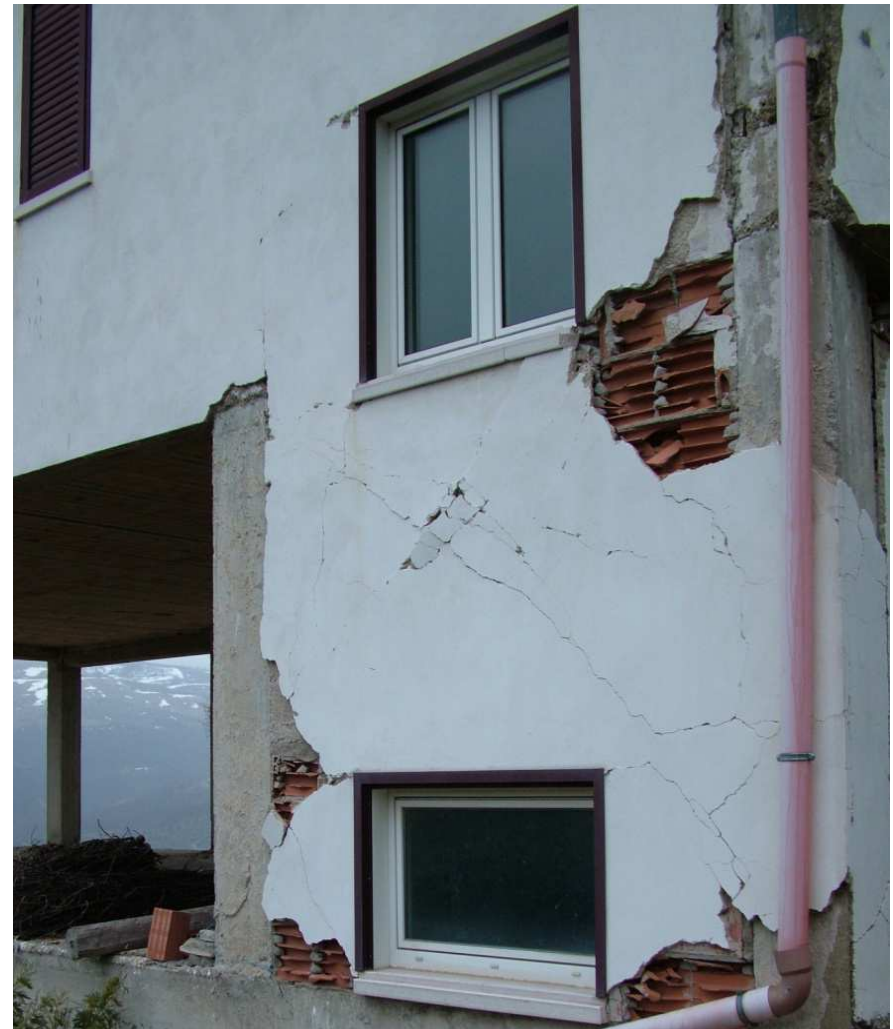
Shear type collapse
mechanism

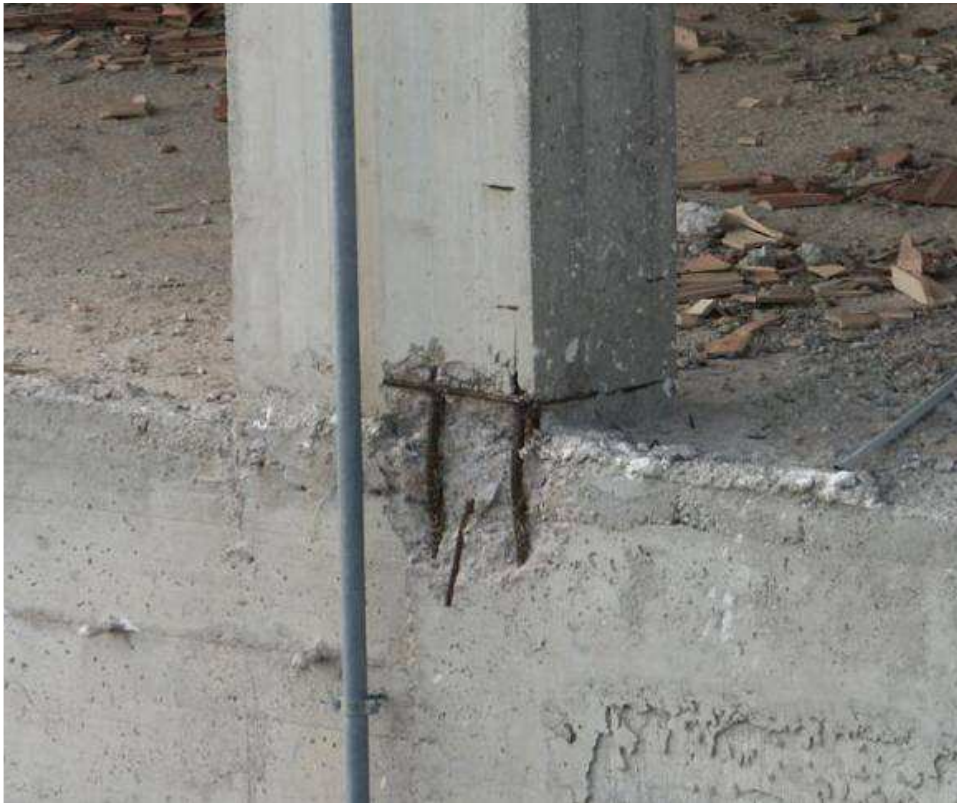
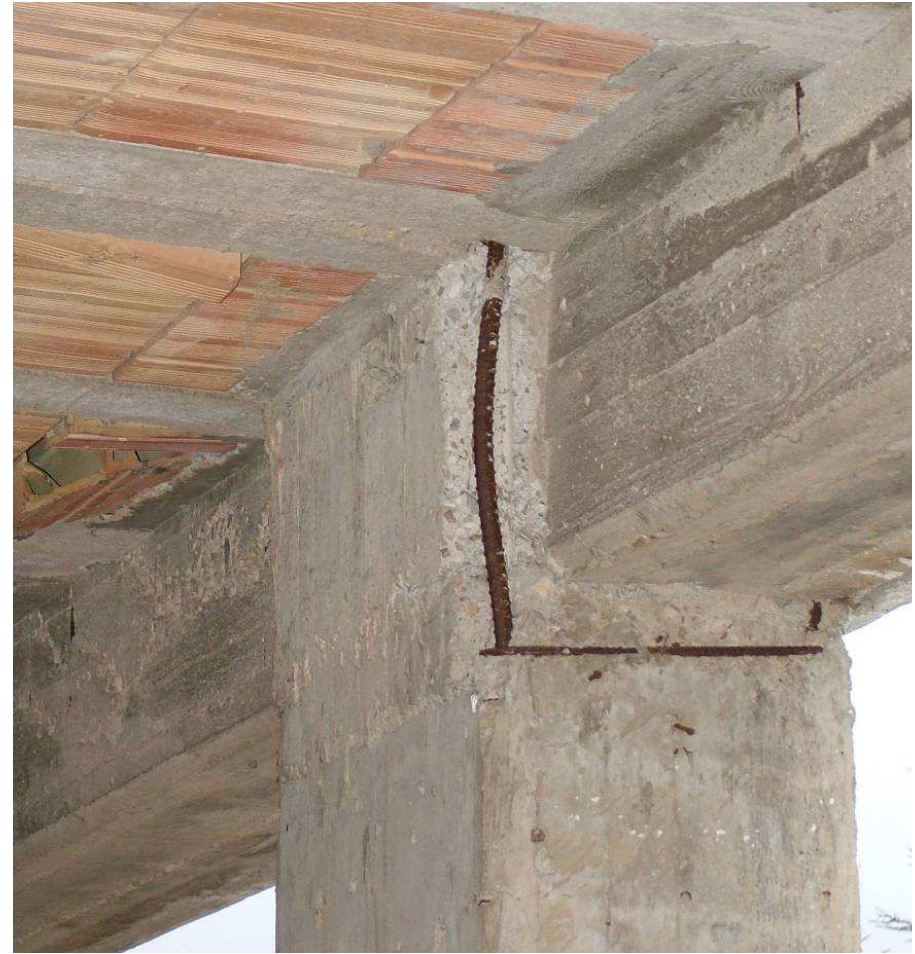
Damages induced by the earthquake

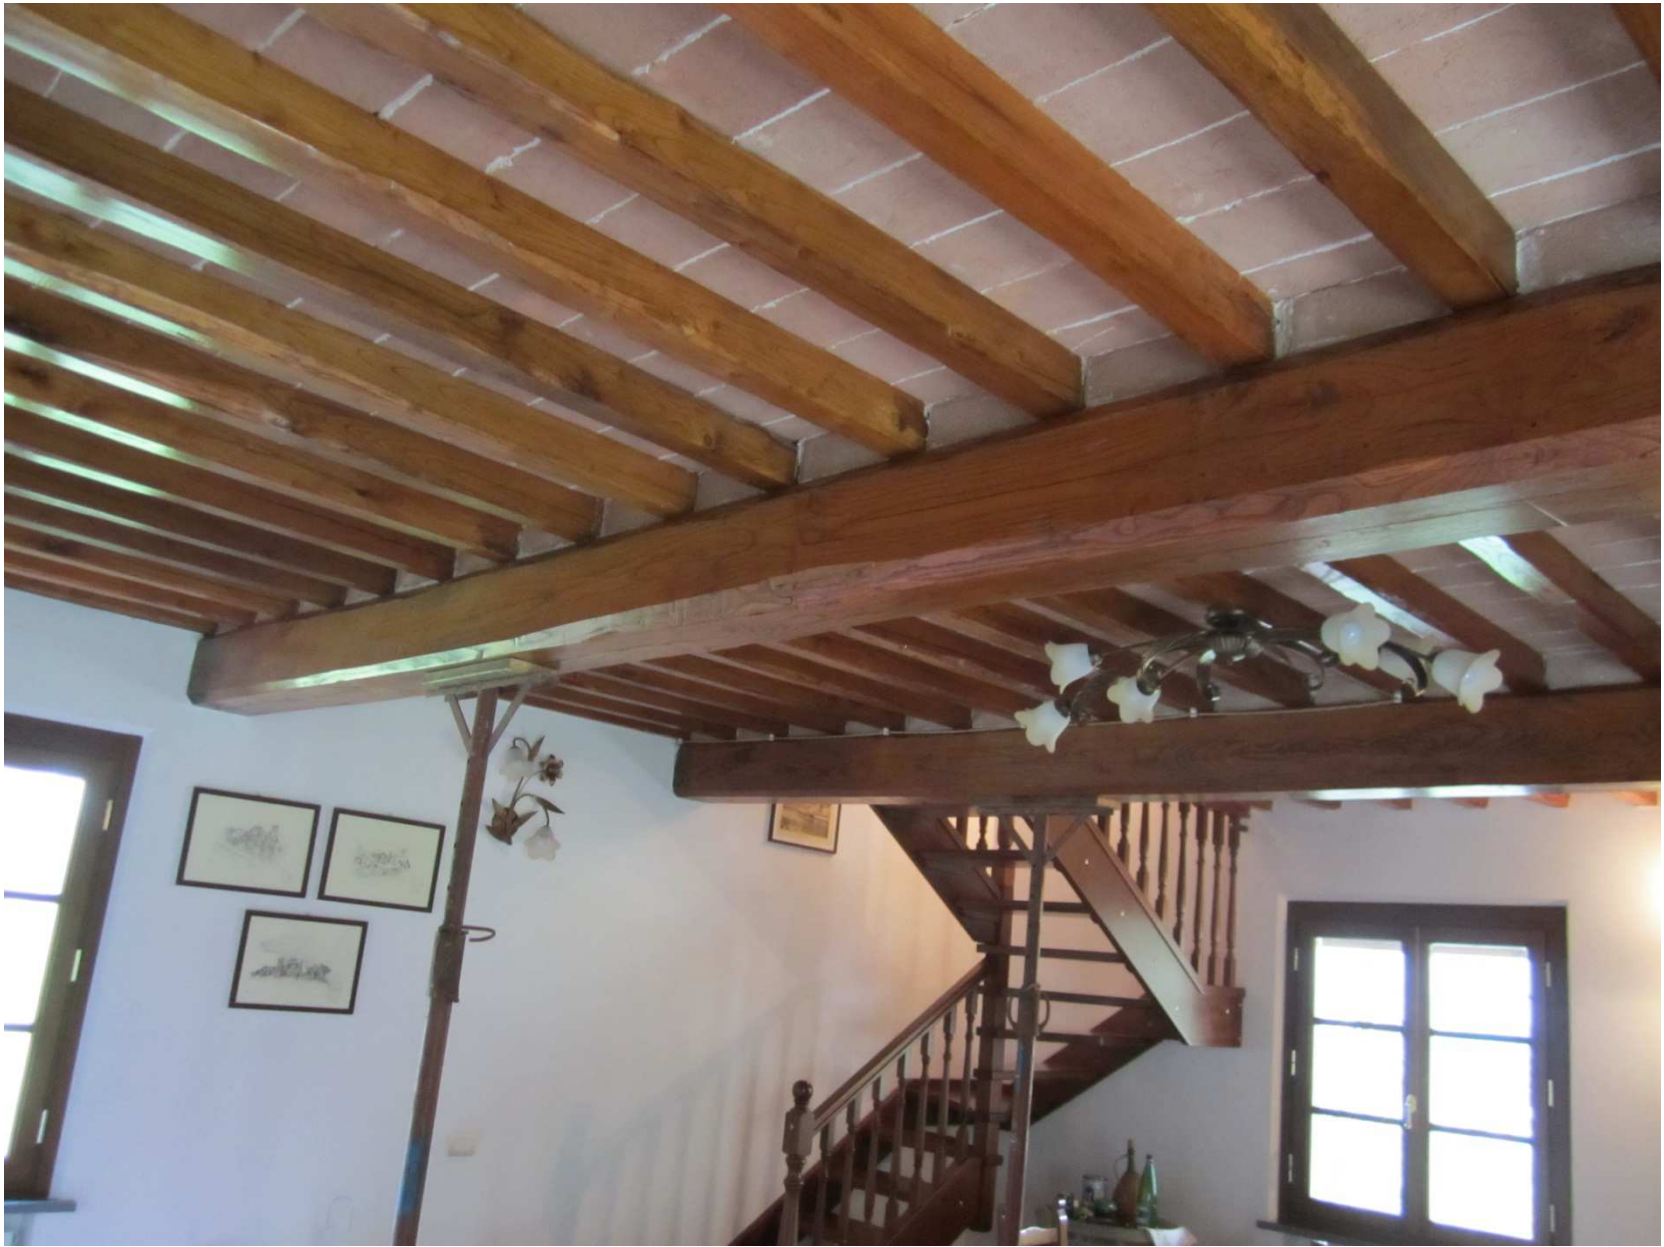
Beams supported with pack props

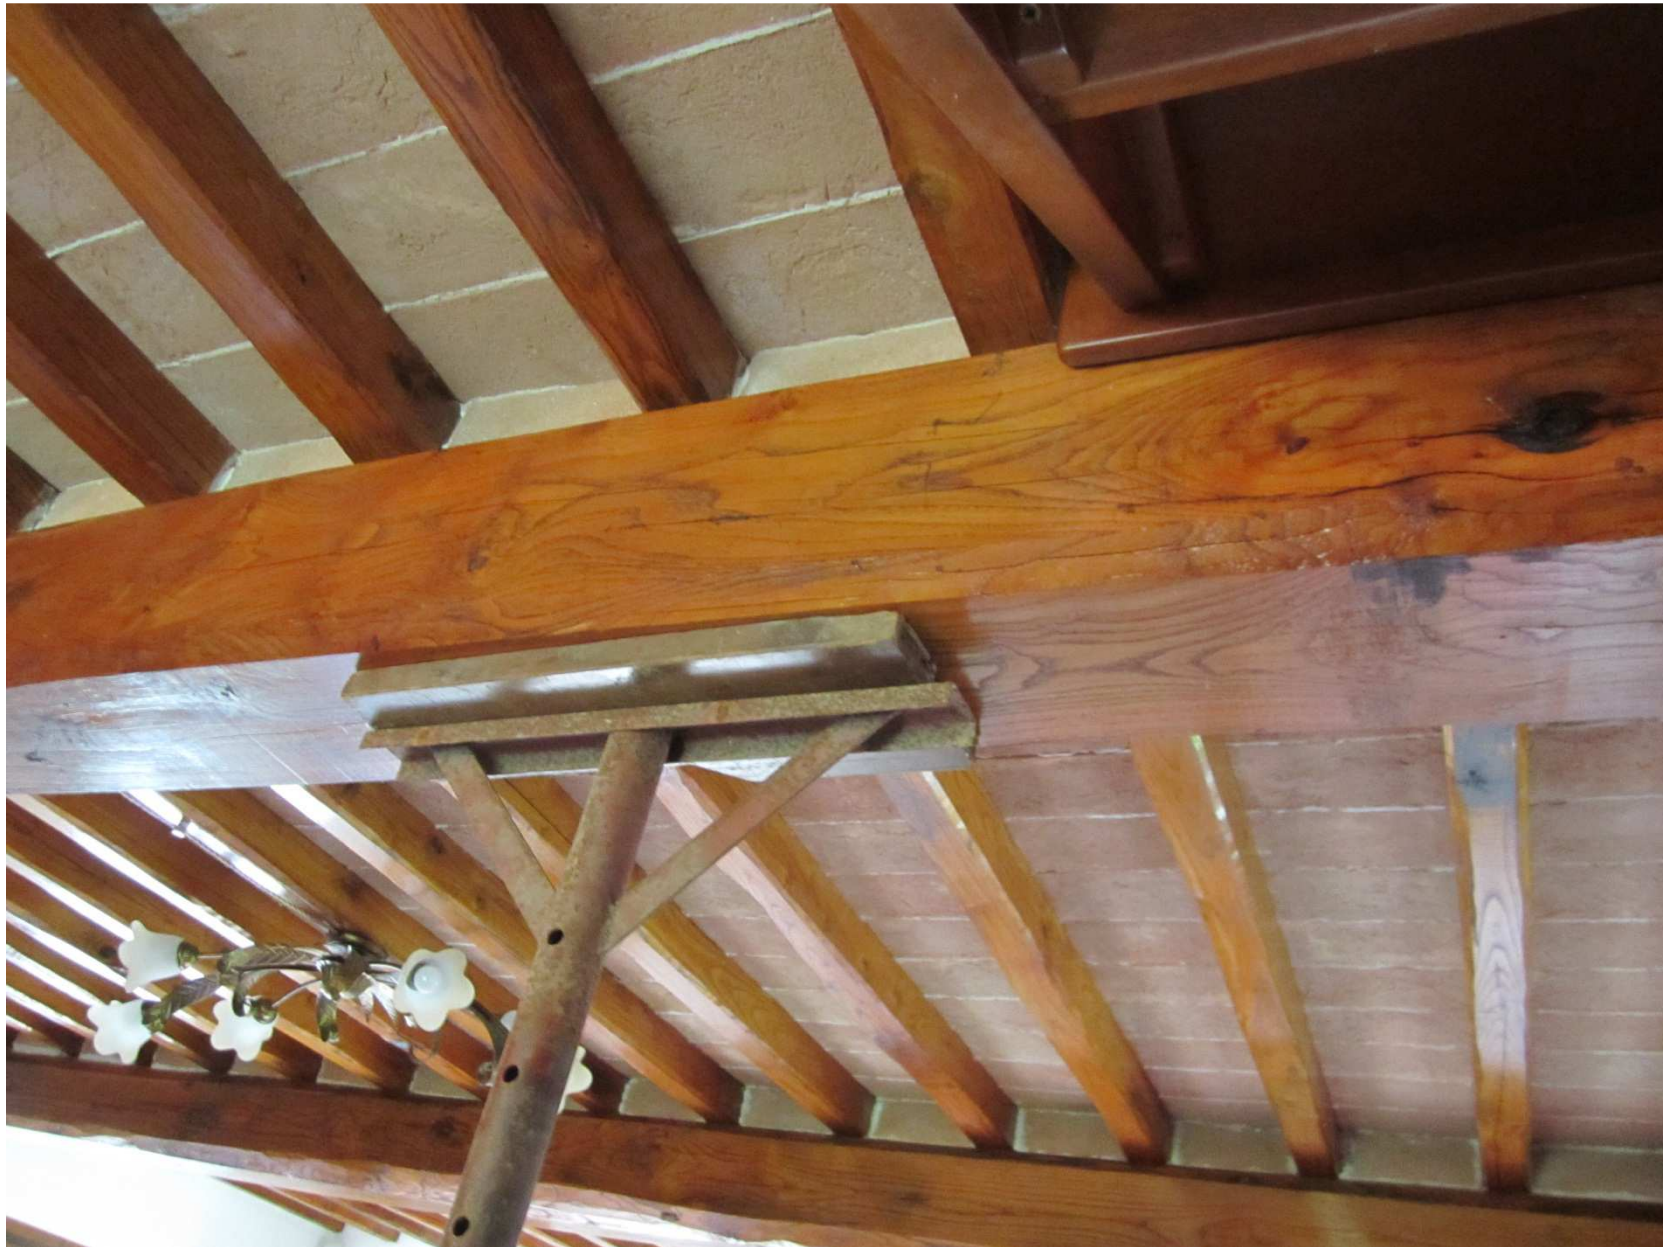
Support and crack

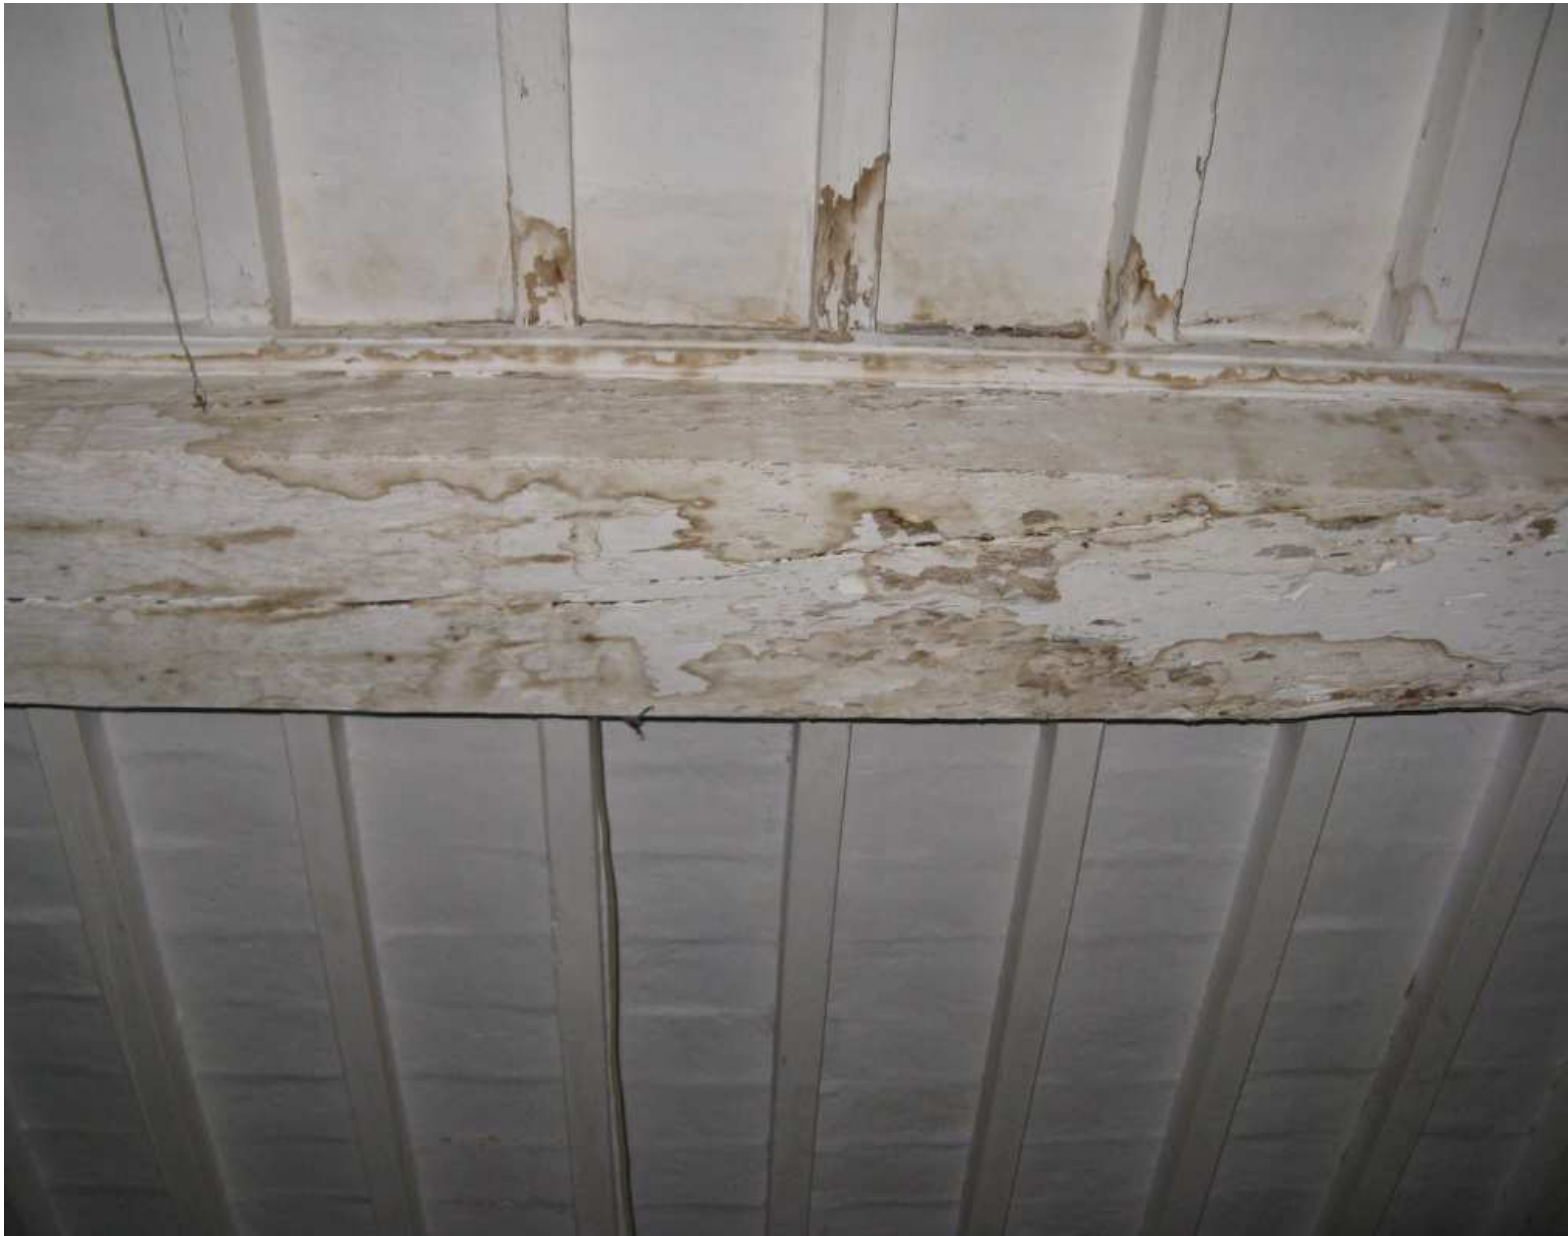
Crack pattern in a beam

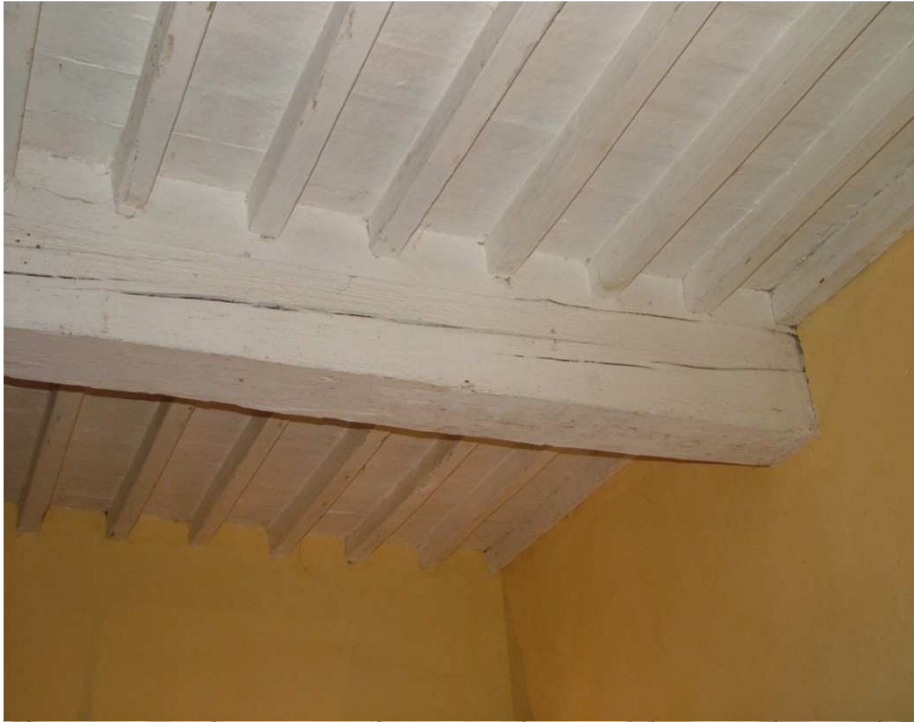
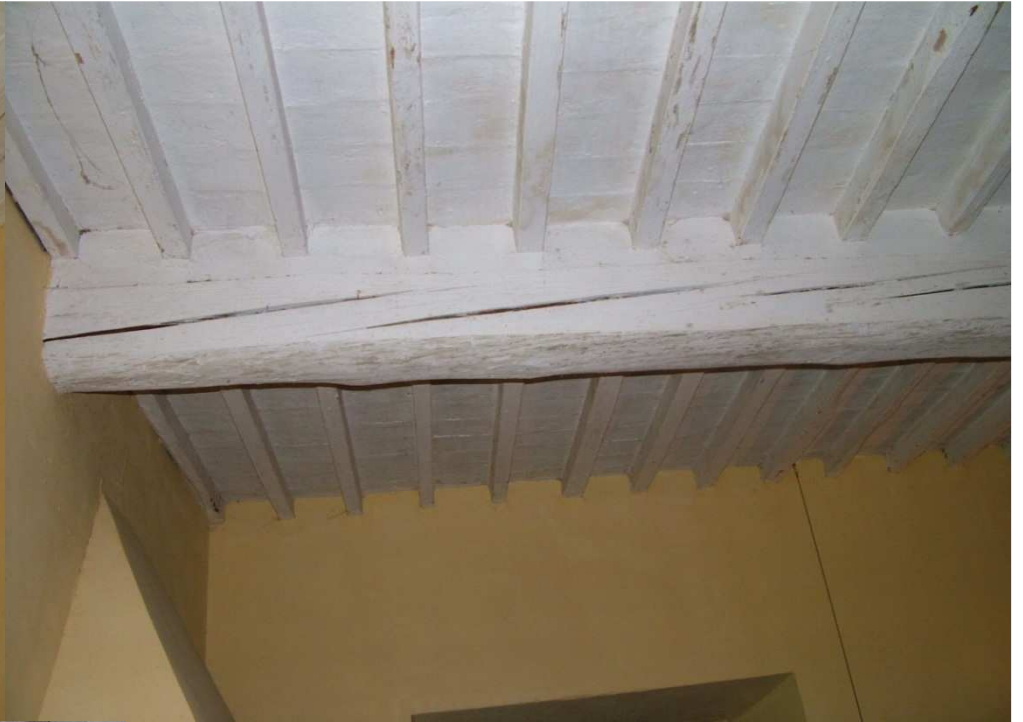
Typical crack pattern
