# SEISMIC PERFORMANCE EVALUATION OF REINFORCED CONCRETE BUILDING IN TURKEY

Assoc. Prof. Dr. Mehmet INEL
Assoc. Prof. Dr. Sevket Murat SENEL

Pamukkale University, Denizli, TURKEY

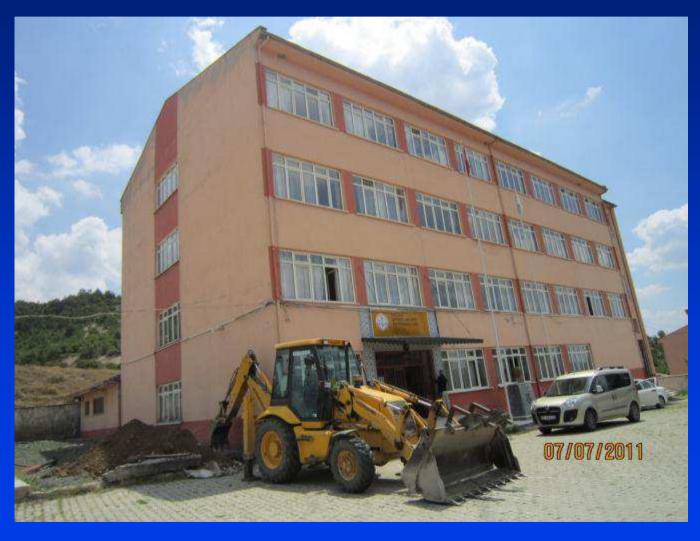
# **Typical School Building**

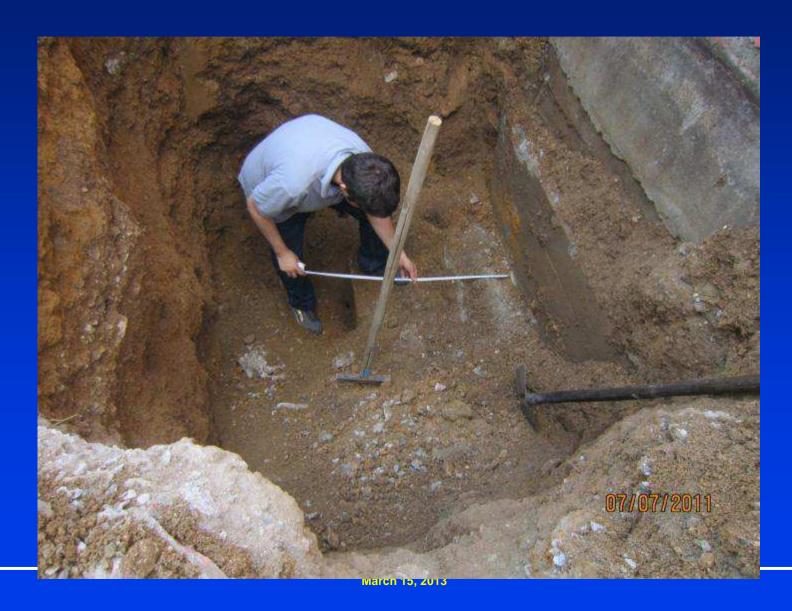
# **Foundation Details and Soil Properties**

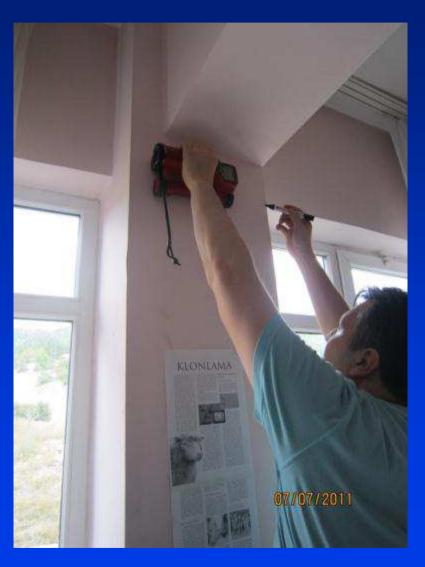
## **Reinforcement Details**

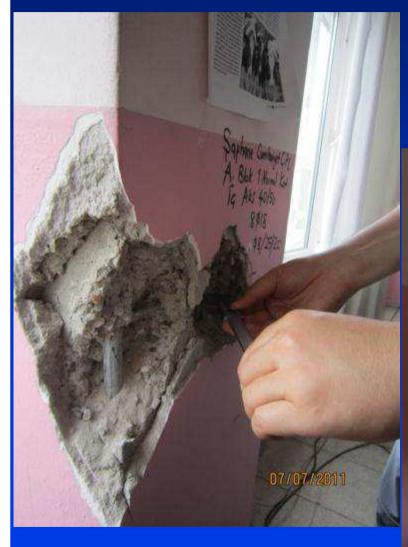
#### **Reinforcement Details**

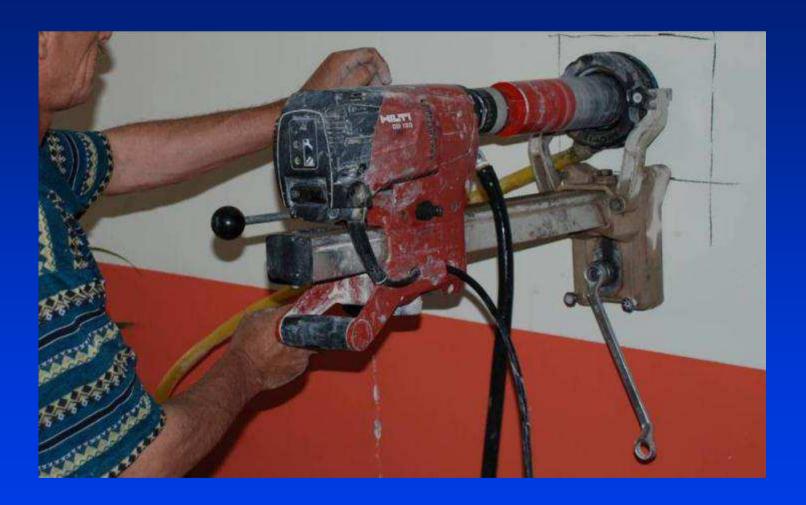
# Concrete Strength: Core Samples

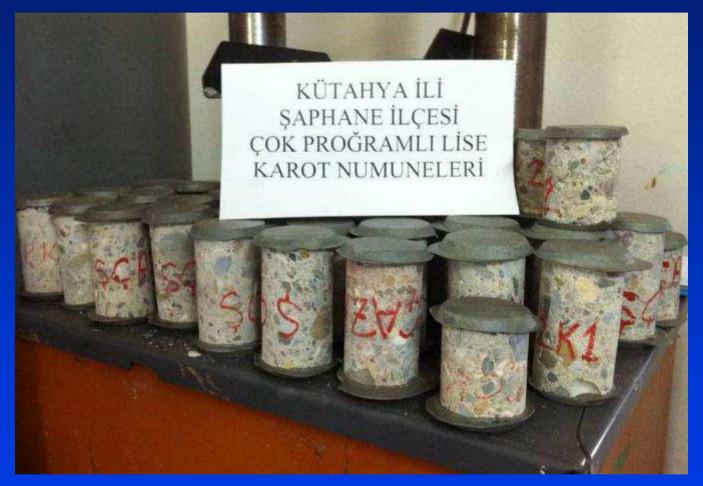
# **Laboratory Testing of Core Samples**

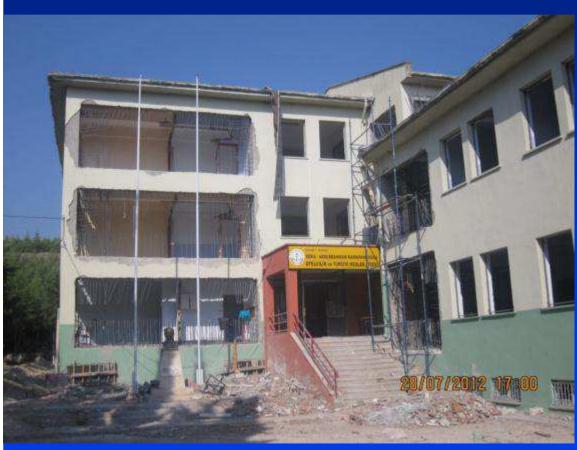
Adding new R/C shear walls by replacing the partition walls

- To increase stiffness capacity
- To increase strength capacity
- To decrease displacement demand

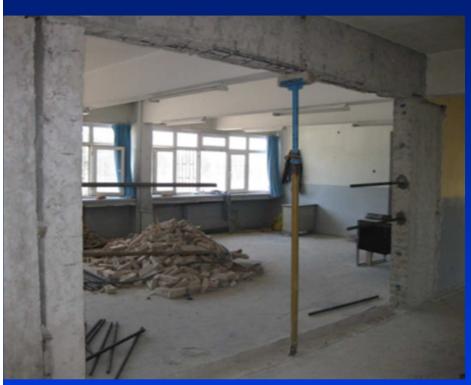
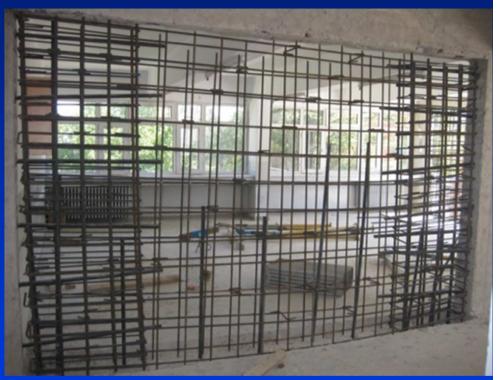
Replacing the partition walls with RC shear walls

**Before** After

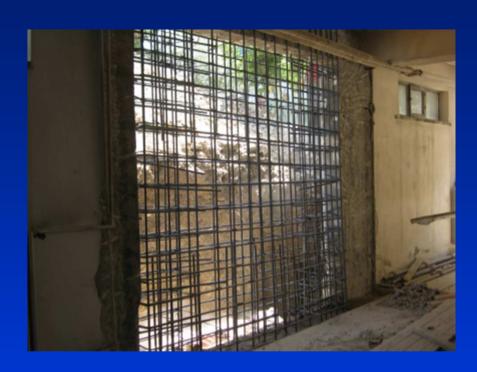
Replacing the partition walls with RC shear walls

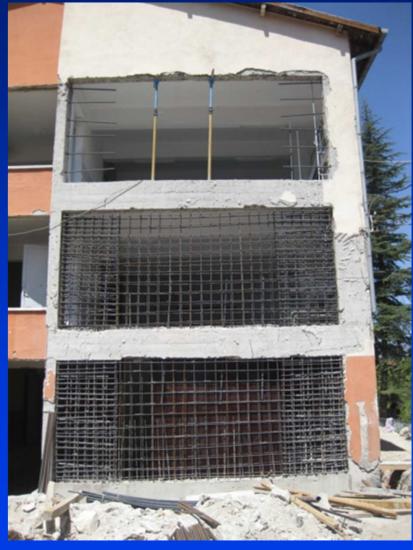
Replacing the partition walls with RC shear walls

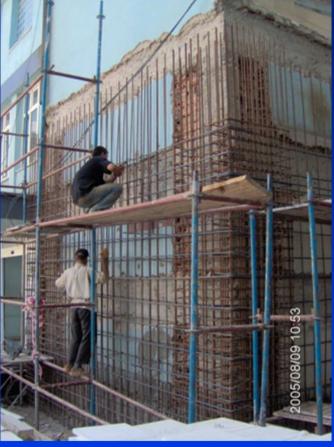
#### Strengthening by using external shear walls

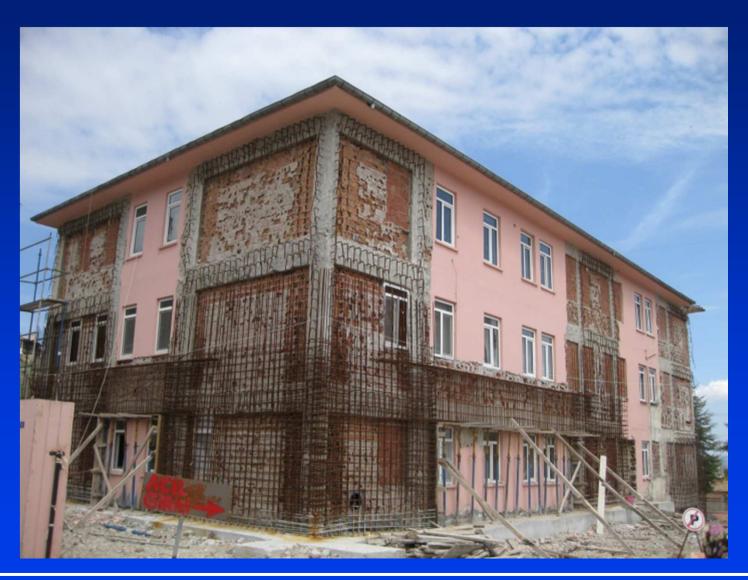
#### Strengthening by using external shear walls

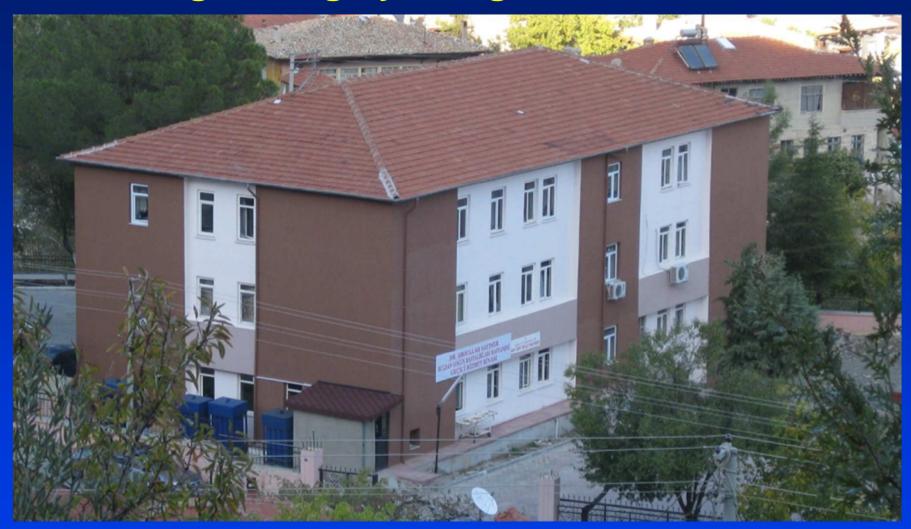
#### Strengthening by using external shear walls

Same building after strengthening

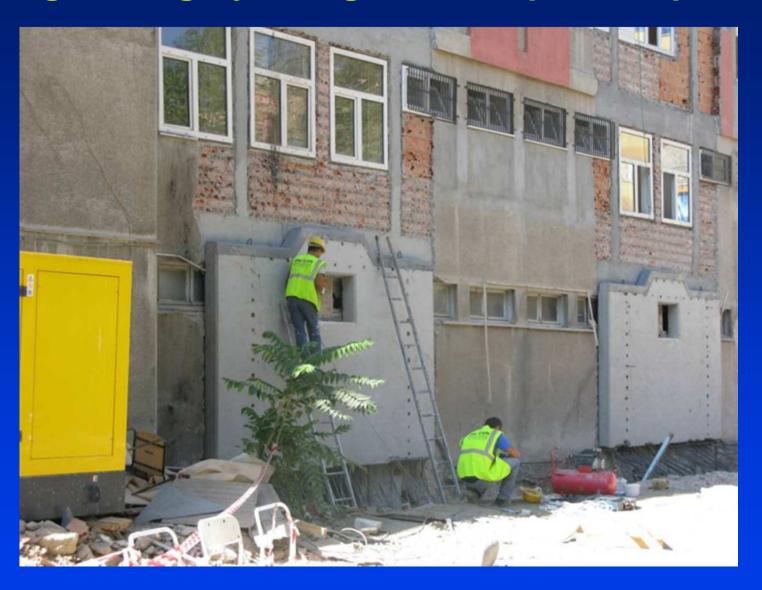
#### Strengthening by using external precast panels

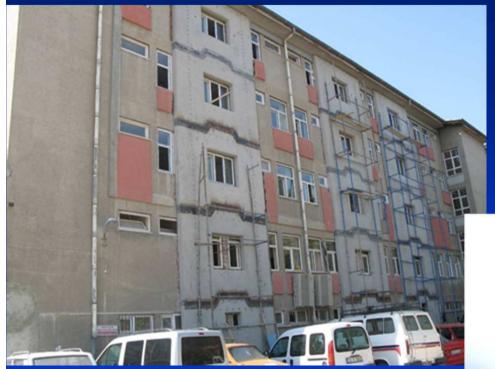
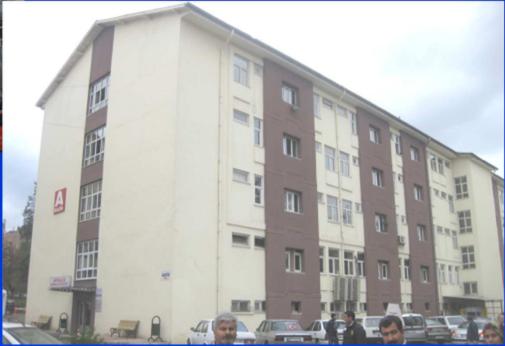
### Strengthening by using external precast panels

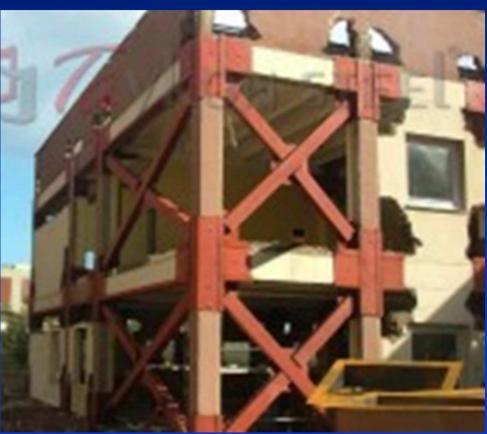
### **Strengthening by using Steel Diagonals**

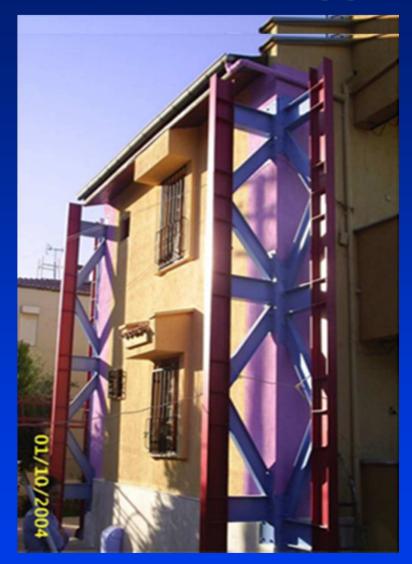
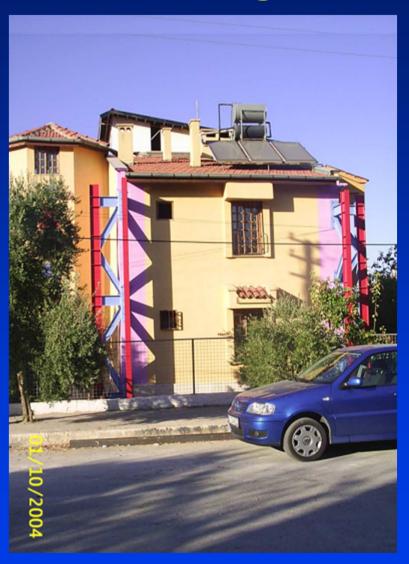
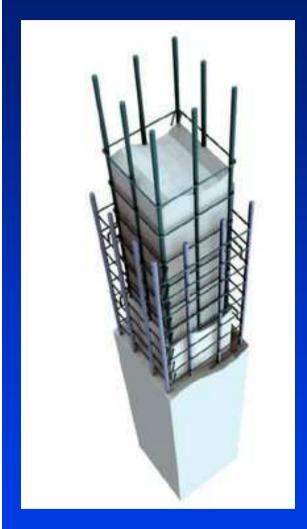
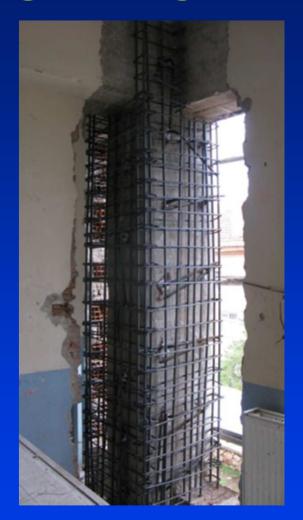
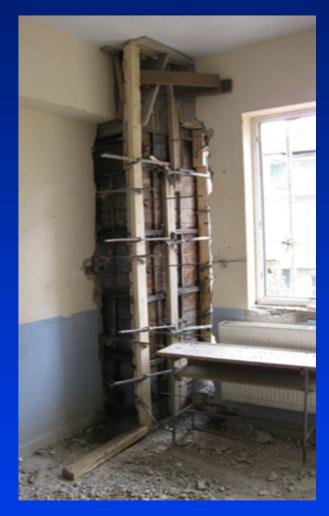
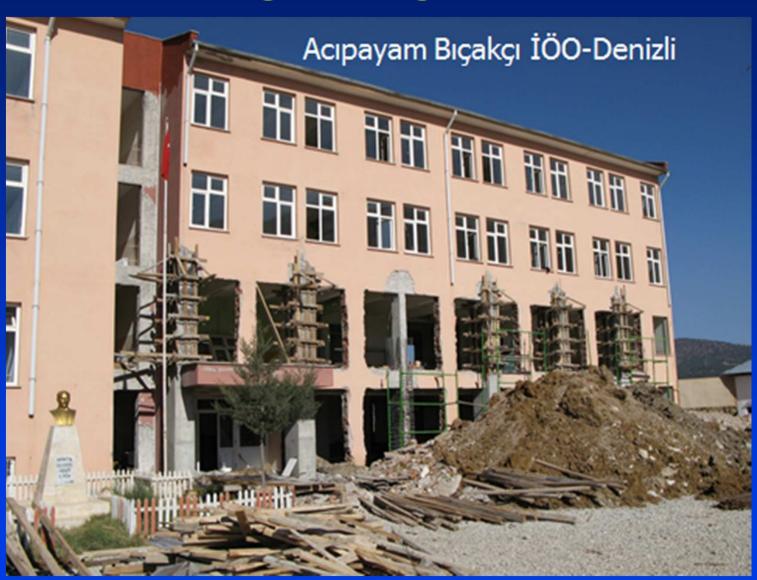
### **External application of steel diagonals**

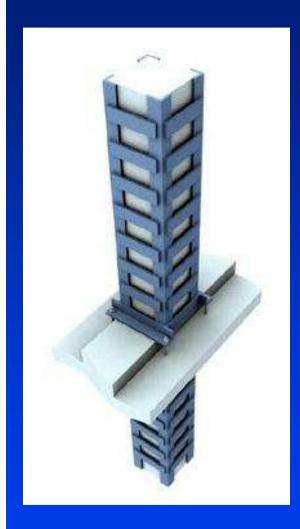
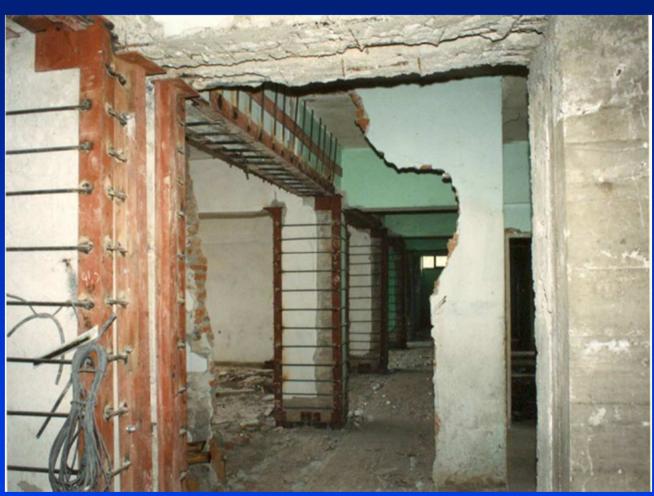
#### Strengthening of Columns by steel jacketing

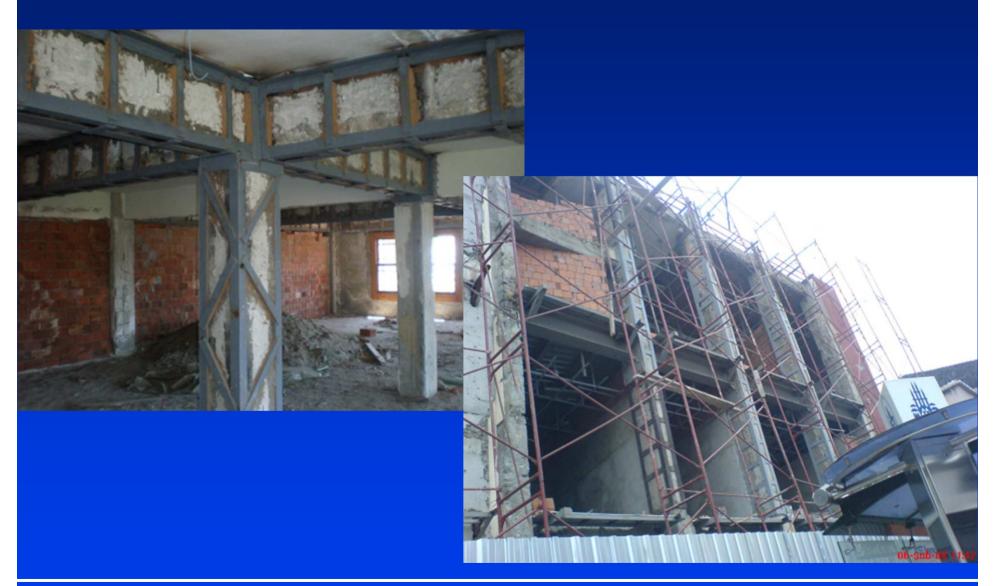
#### Strengthening of Columns by steel jacketing

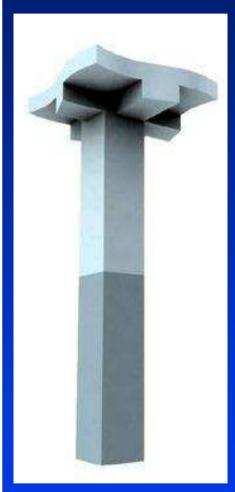
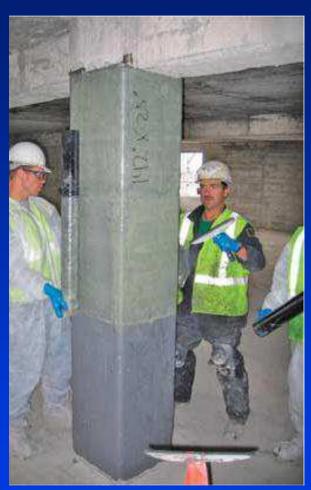
#### **Strengthening of Columns by using FRP**

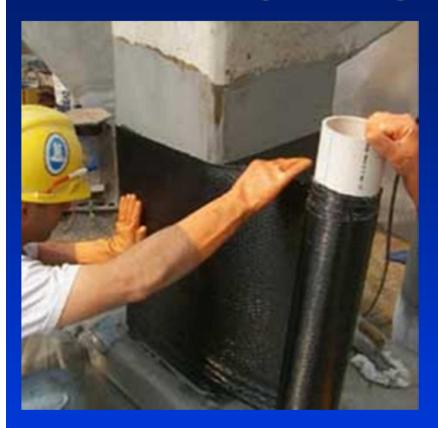
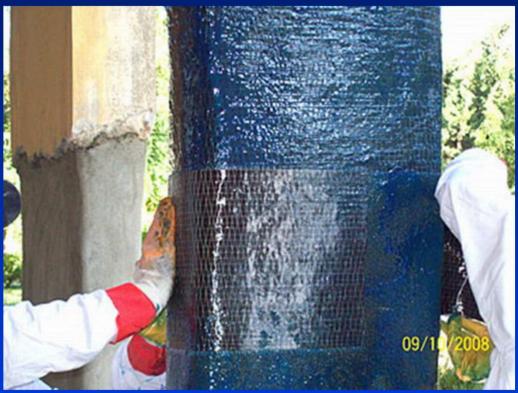
#### **Strengthening of Columns by using FRP**

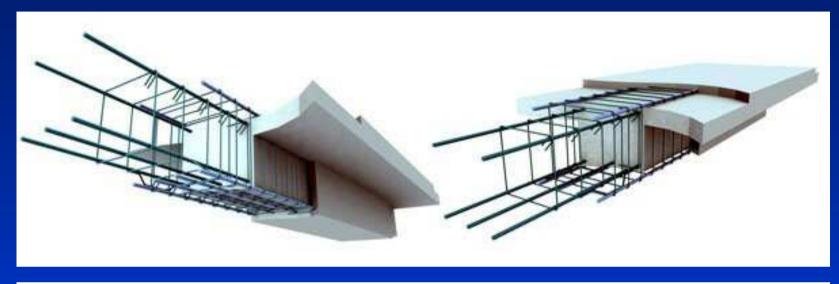
# **Strengthening of RC Beams**

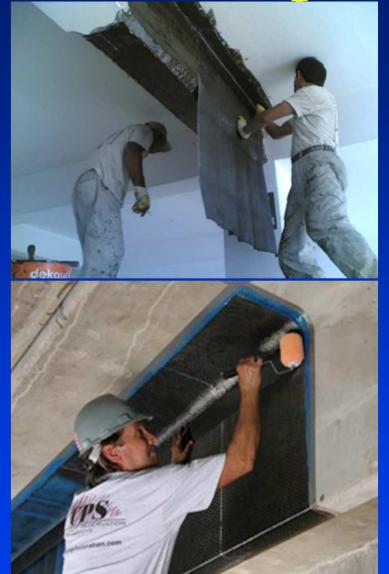
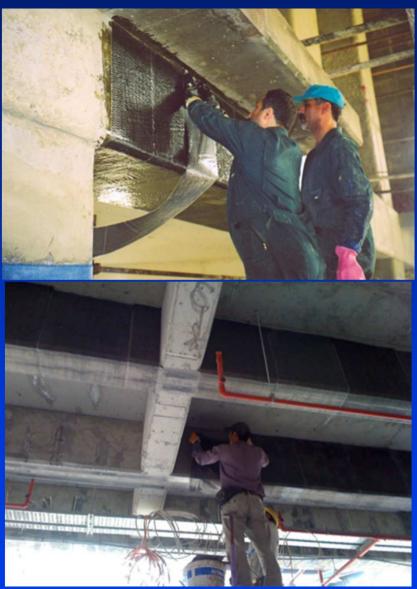
**Strengthening of RC Beams**

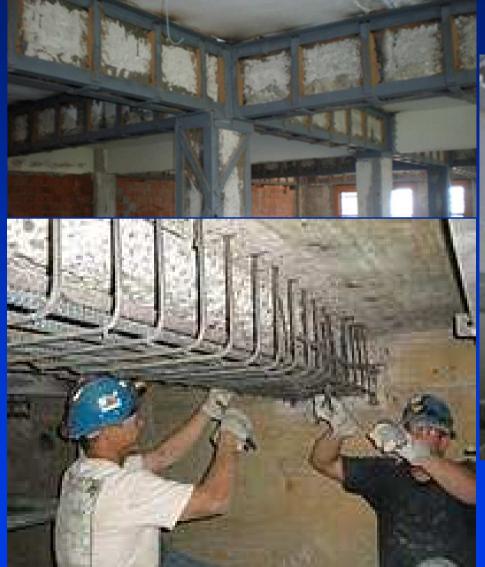
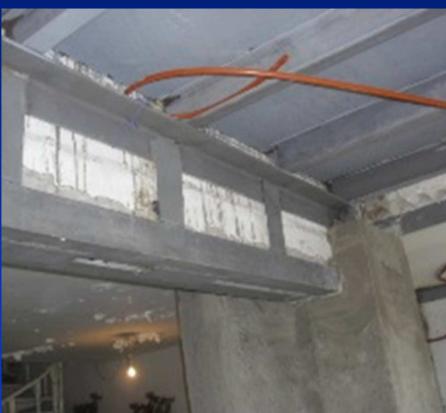
# **Strengthening of RC Beams**

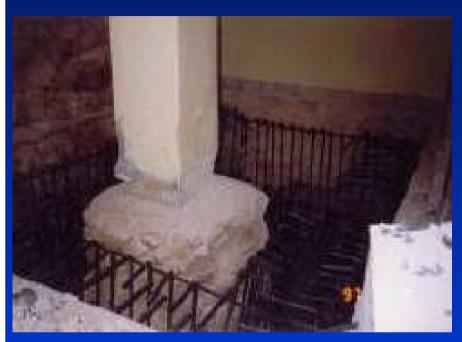
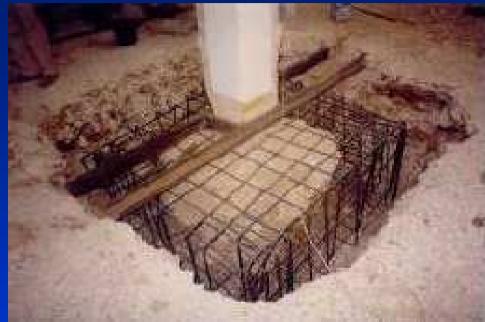
# **Strengthening of Foundations**

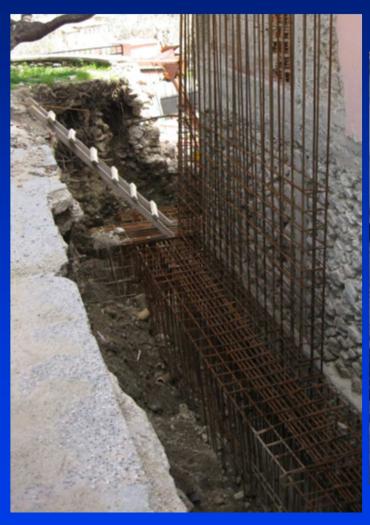
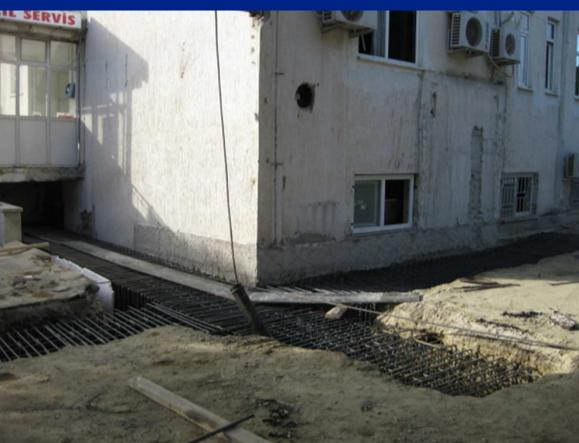
# **Strengthening of Foundations**

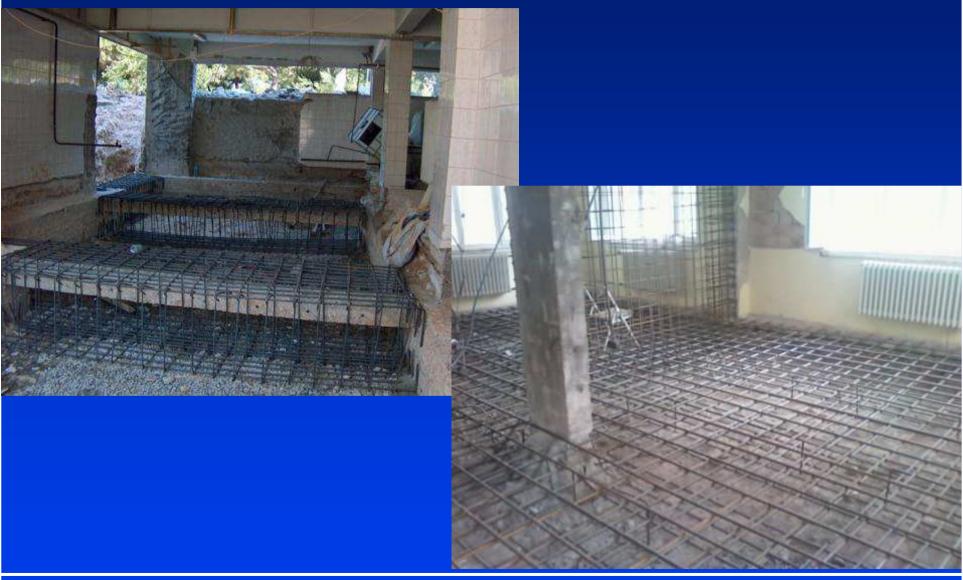
# **Strengthening of Foundations**
