Concrete structures

Case studies

Leonardo da Vinci
Assessment of existing structures
Project number: CZ/08/LLP-LdV/TOI/134005

CASE STUDY N. 1

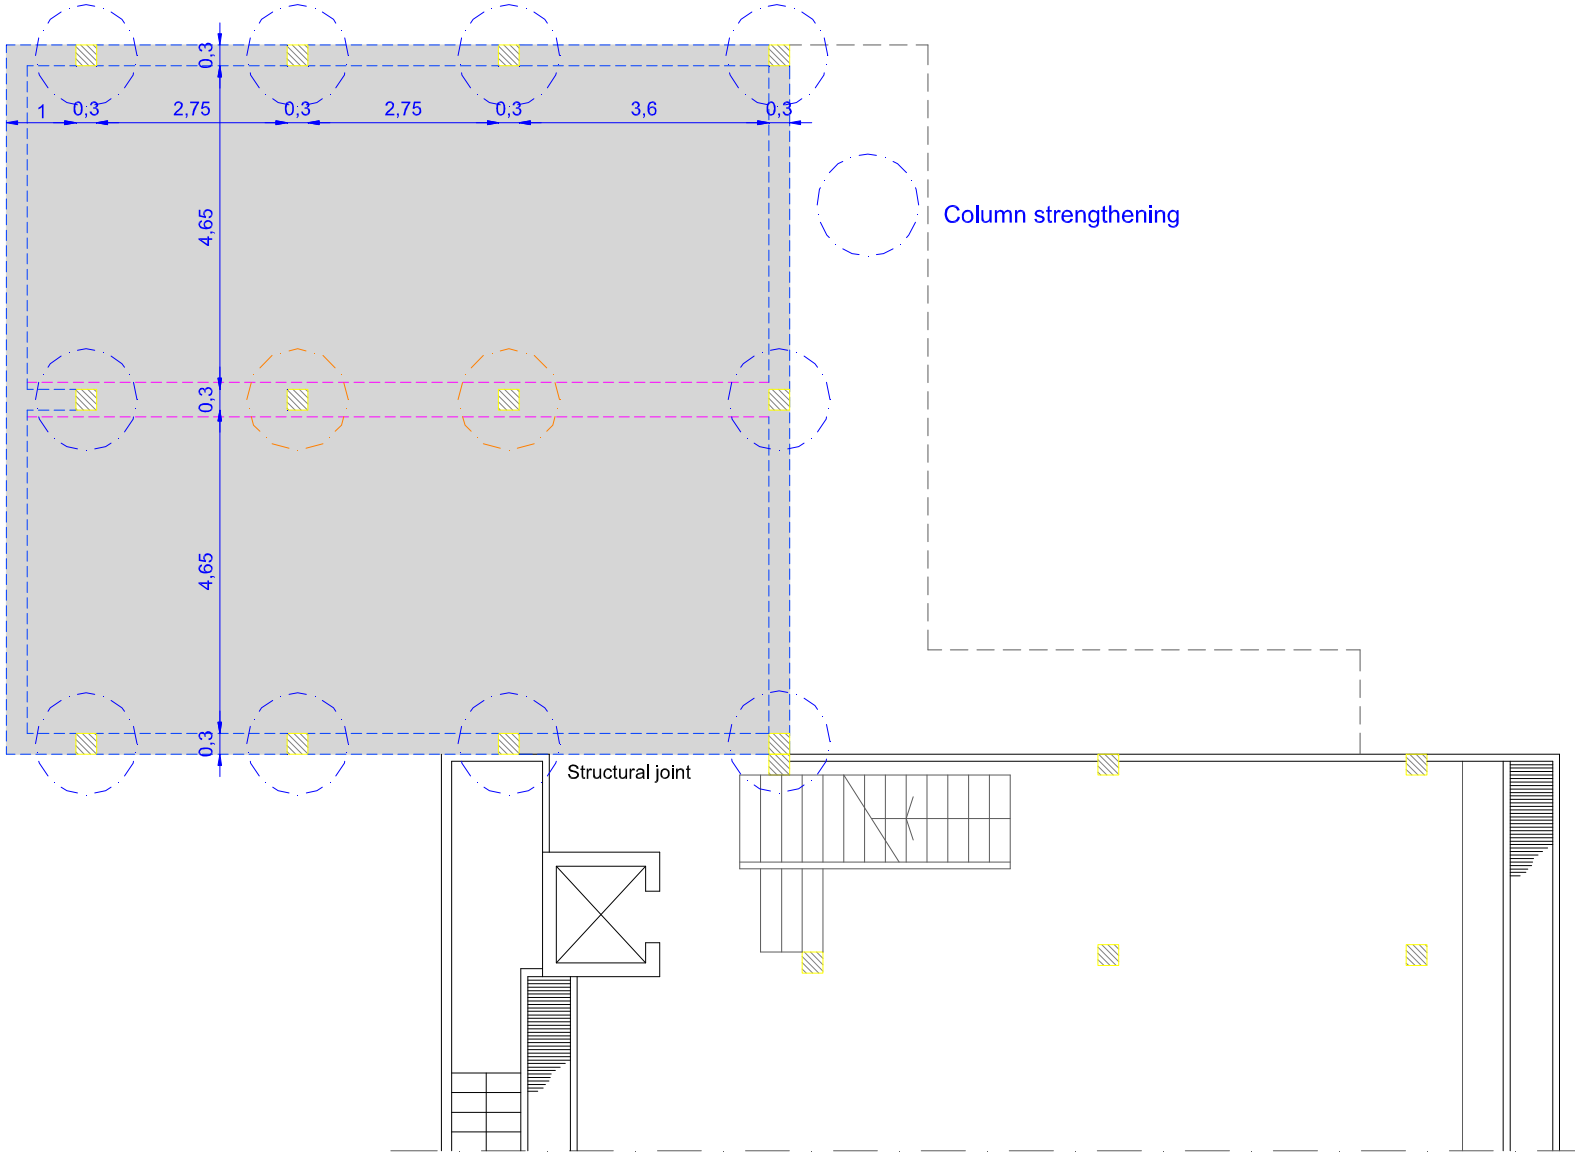
Building plan with indication of columns to be strengthened

Damaged columns

Corroded rebars

Cracking of concrete cover

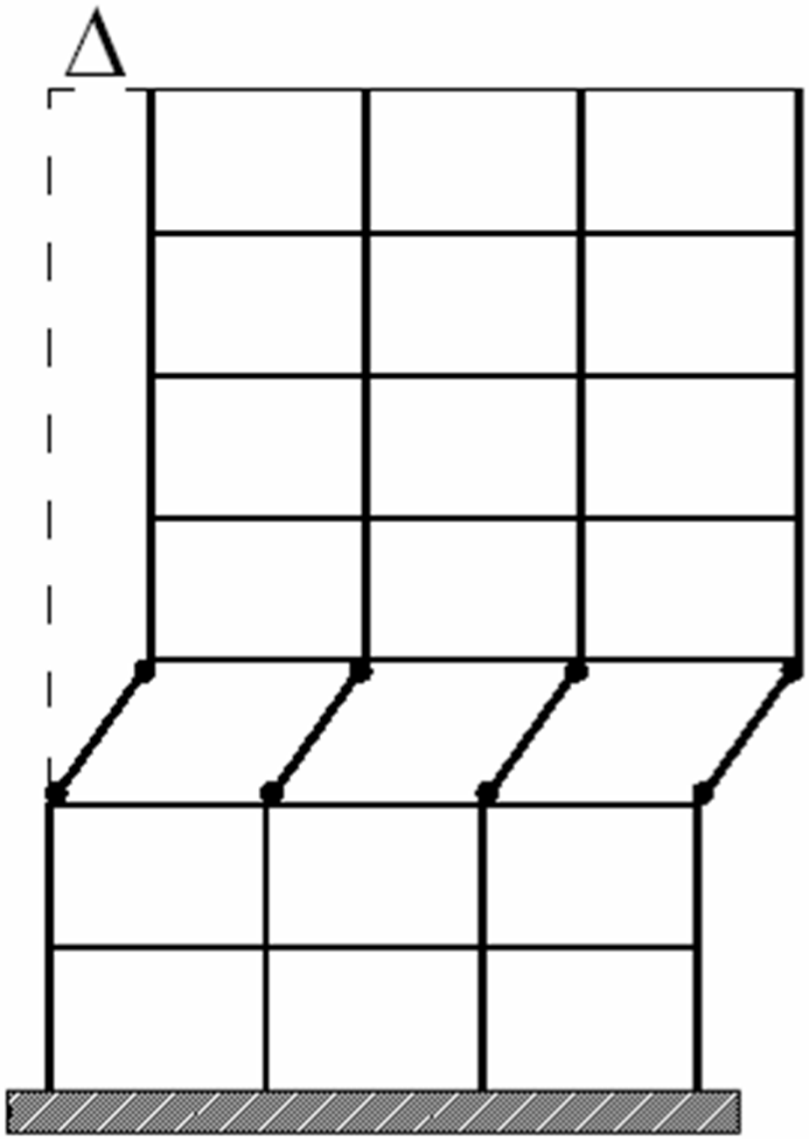
Shear type collapse mechanism

Damages induced by the earthquake

Damages at the ends of the columns
