# Timber structures

## Case studies

PIETRO CROCE

Assessment of existing structures

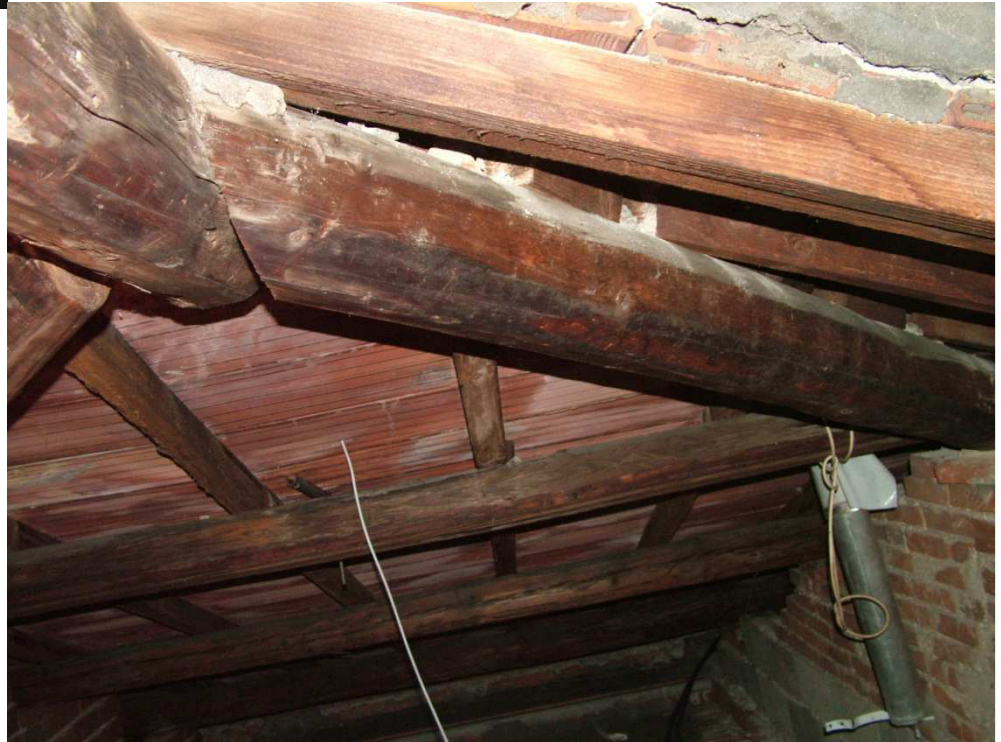
Crack pattern in a beam

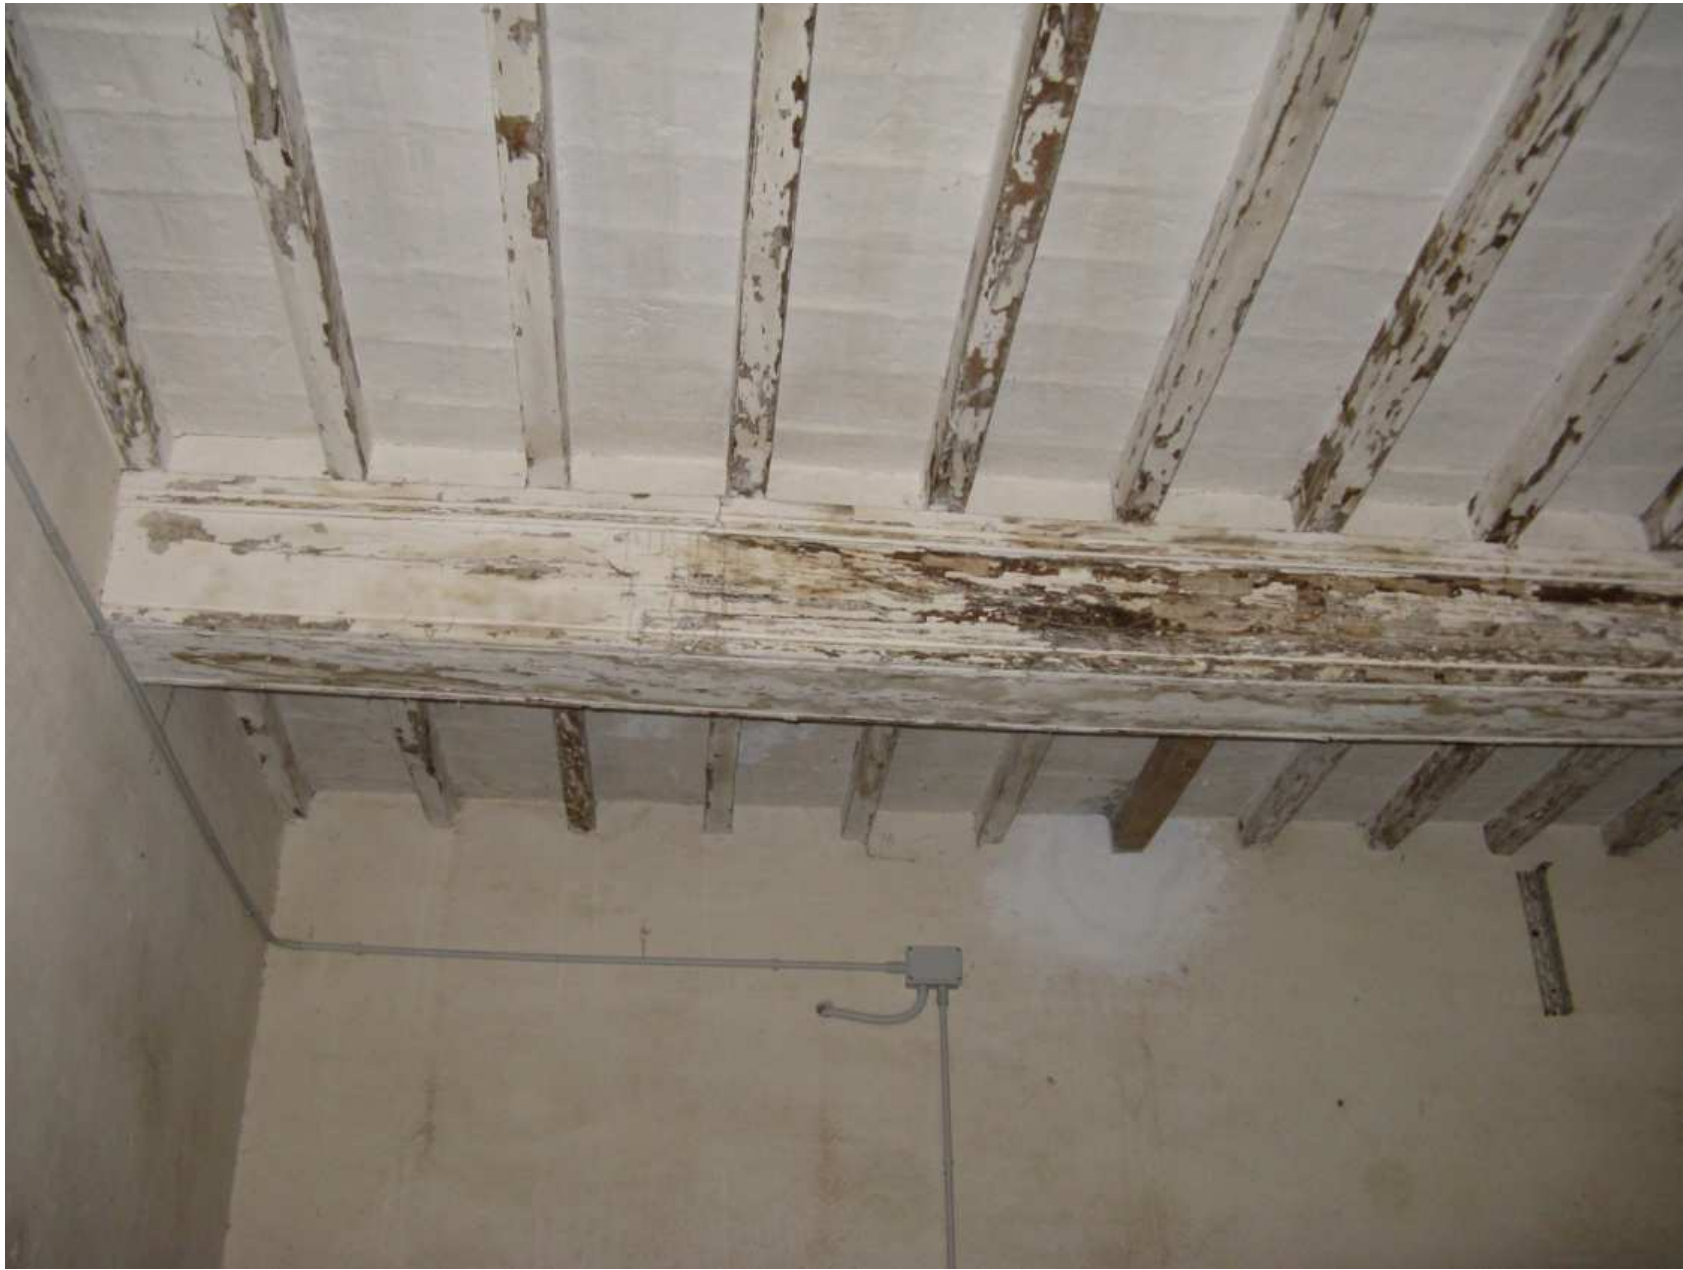
**Beam covered with wood plates**

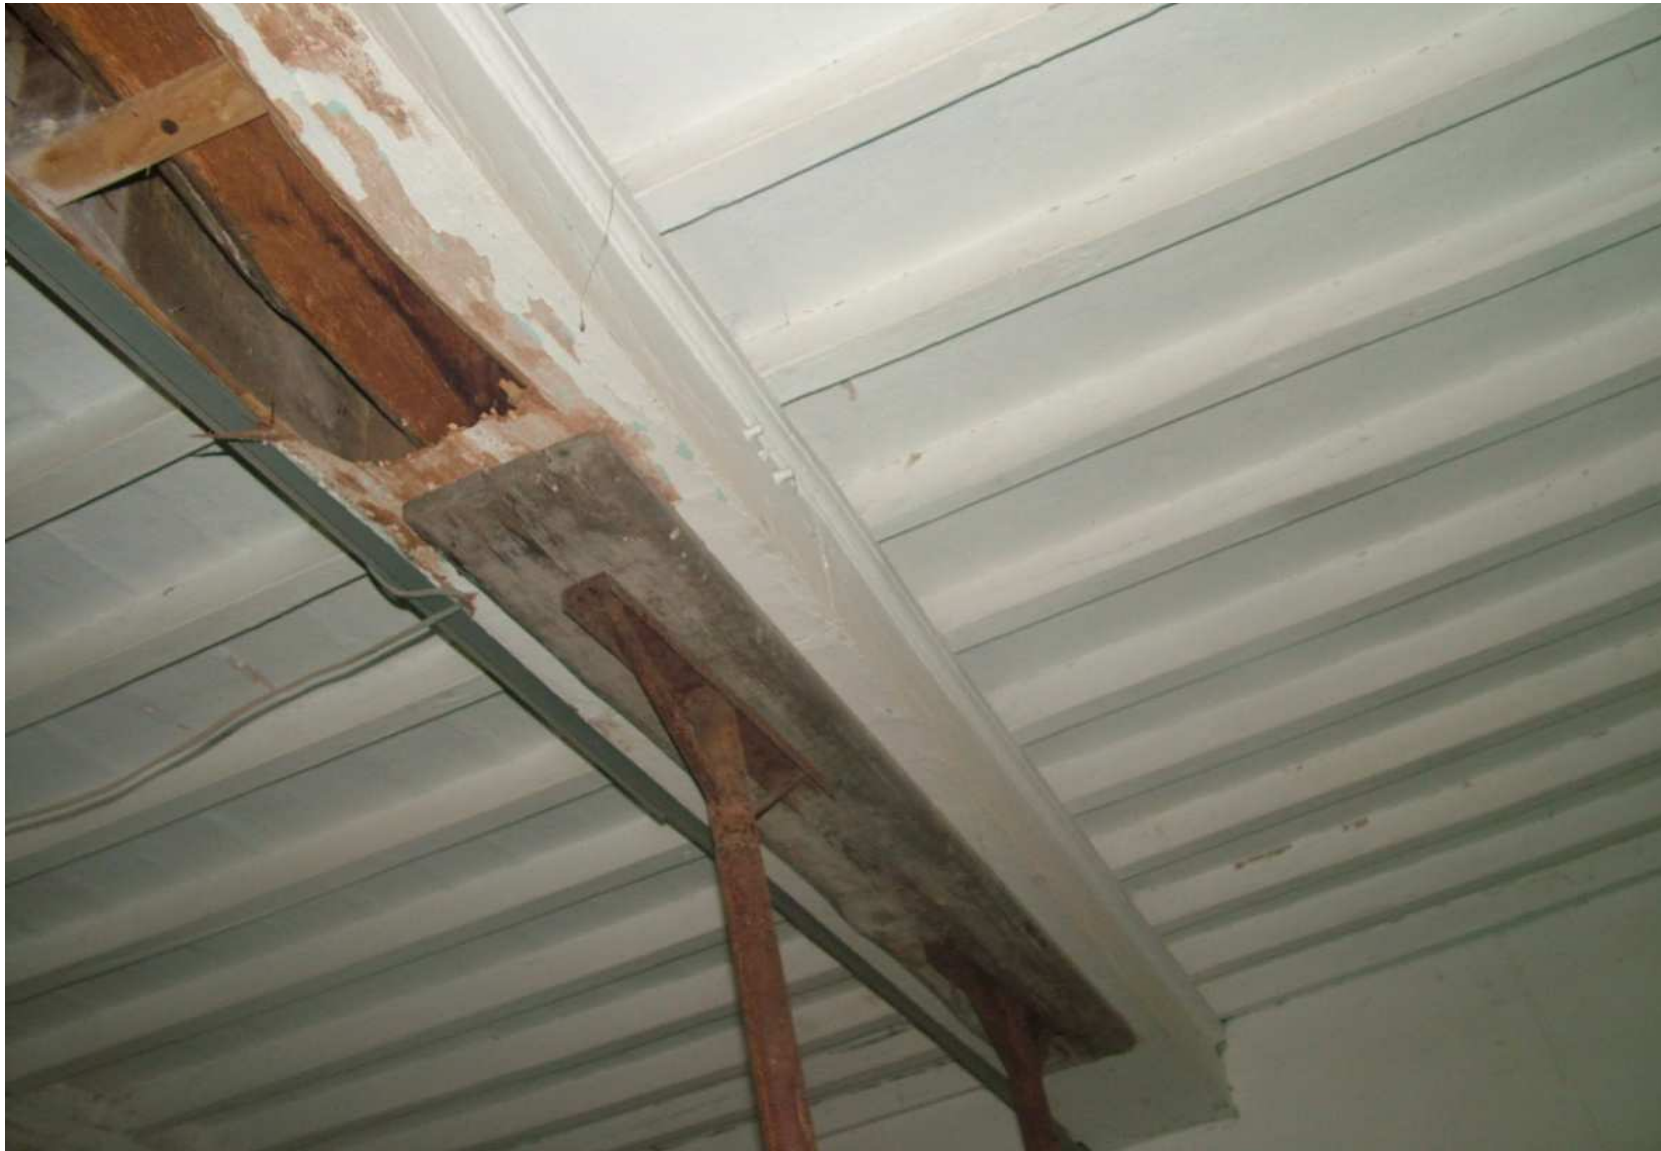
**A surprising arrangement of the cover**

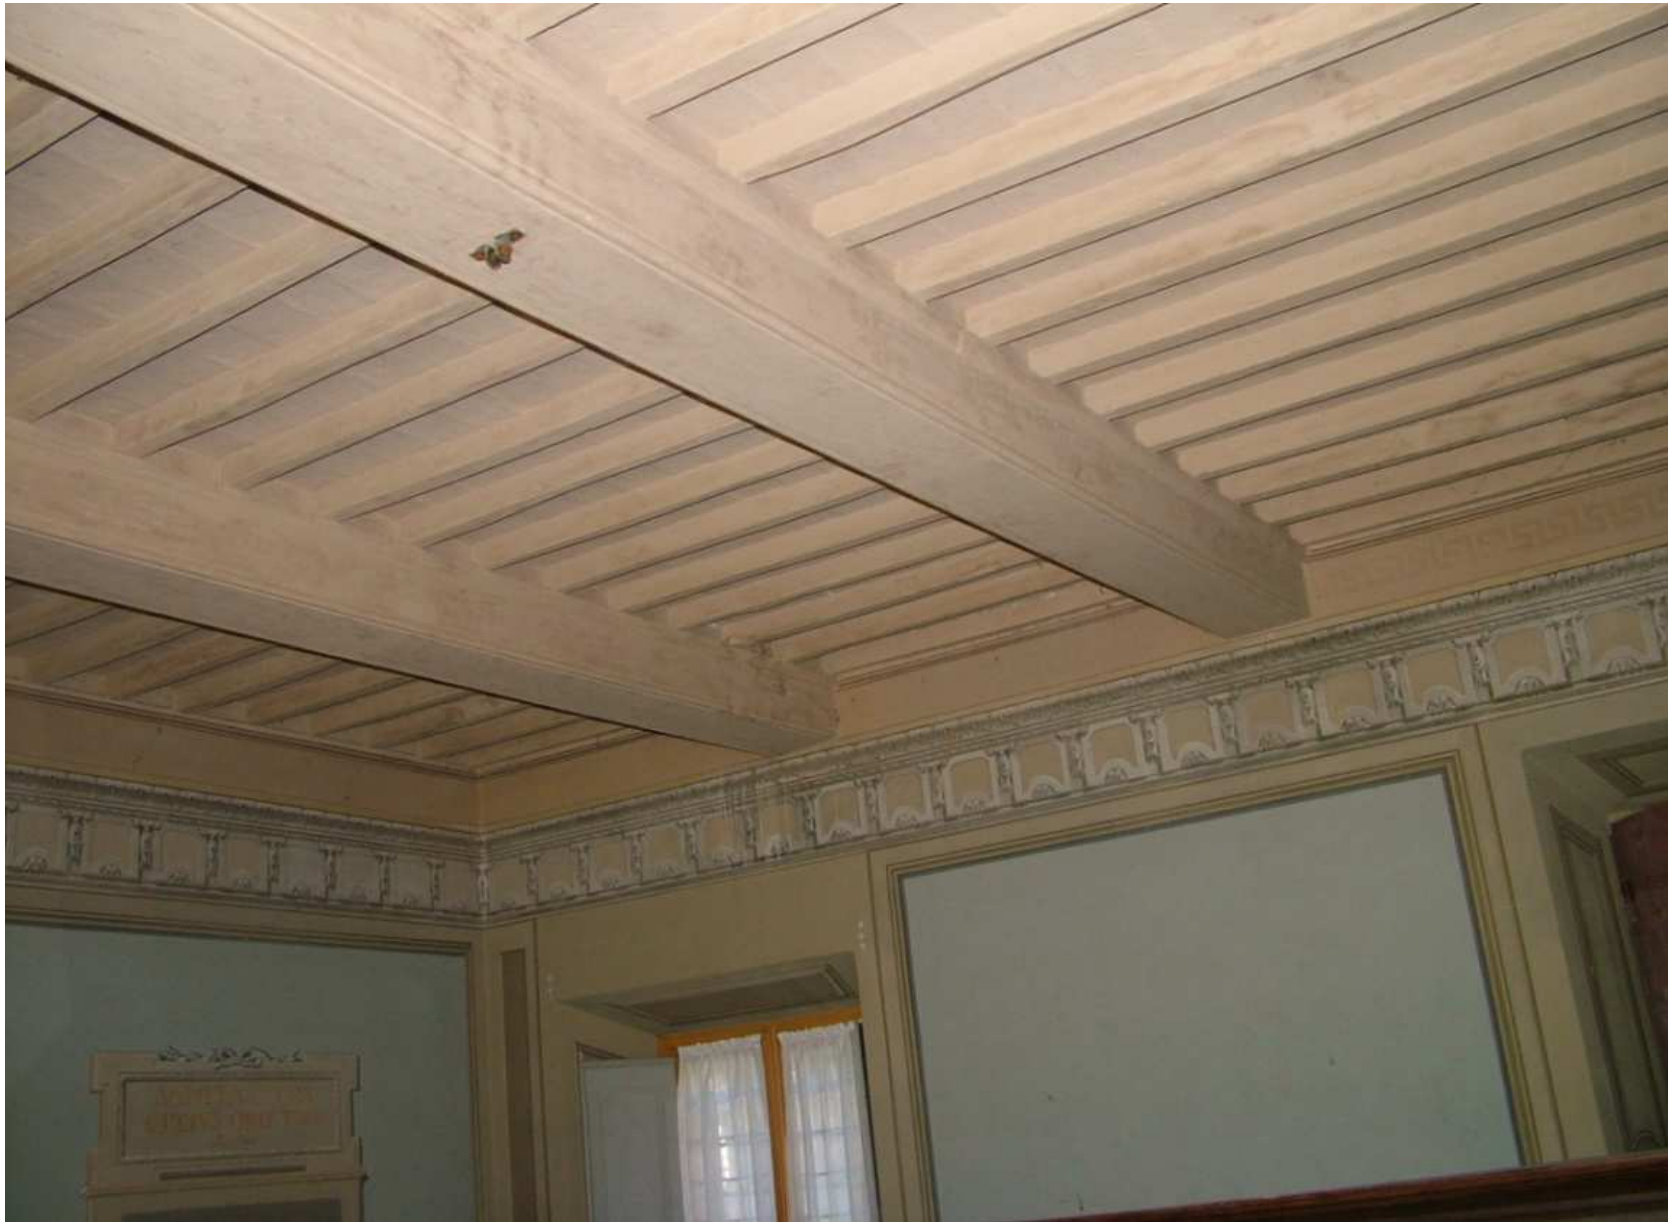
Covered beams

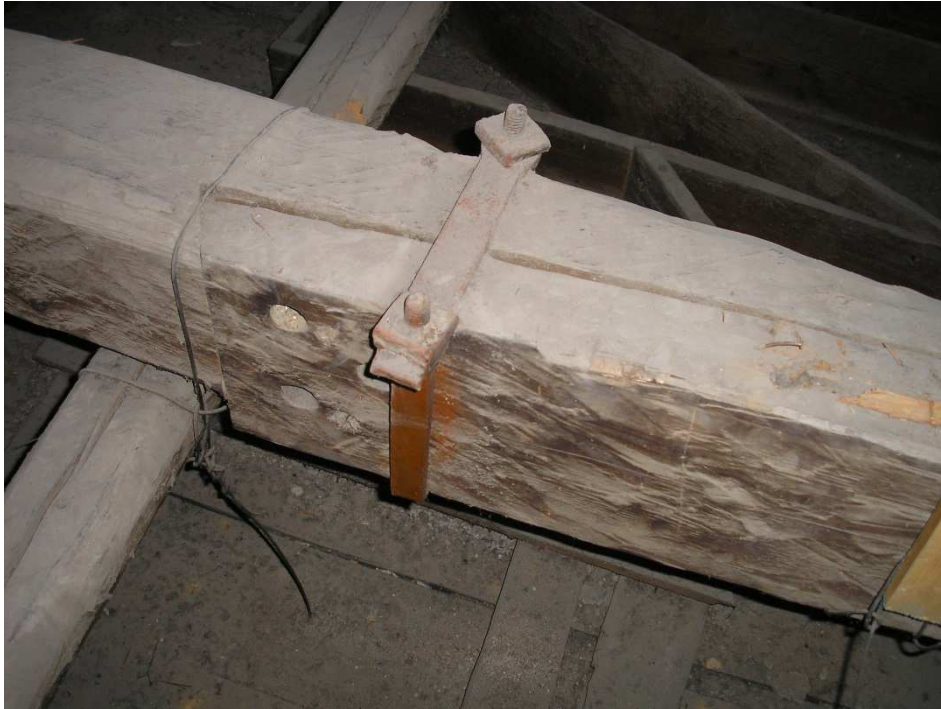
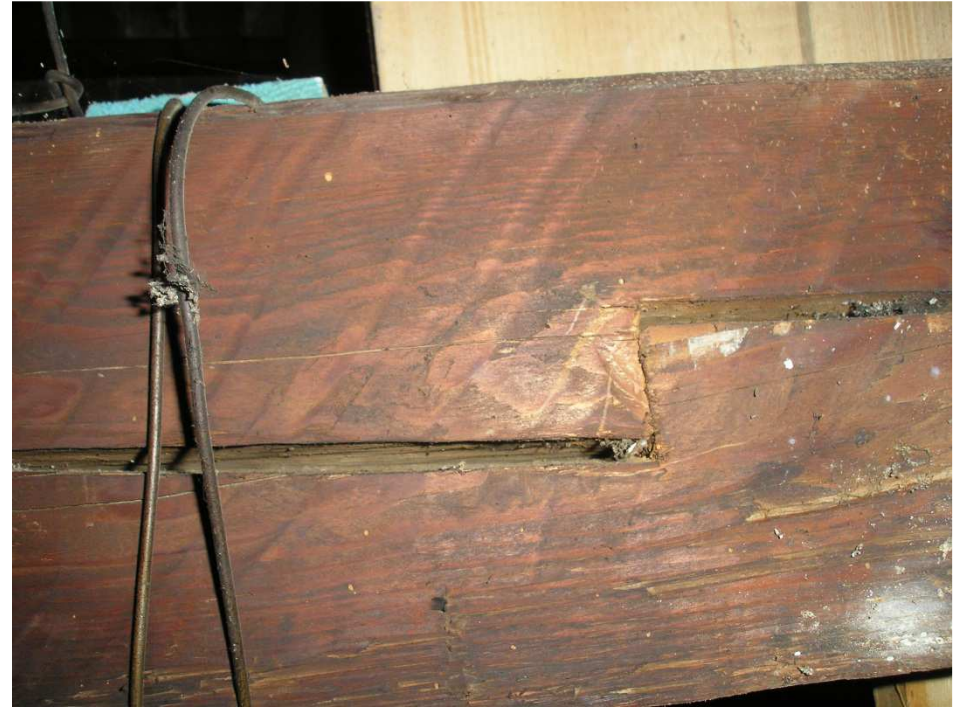
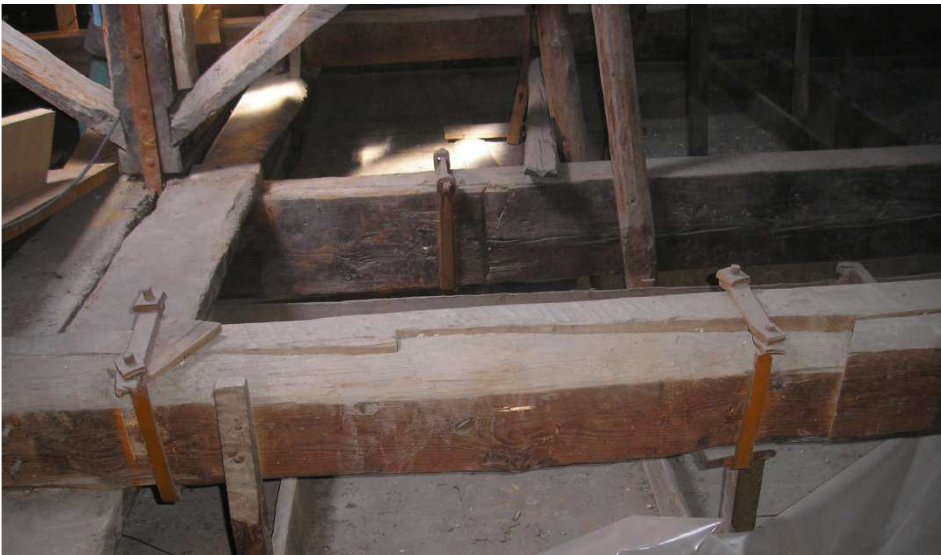
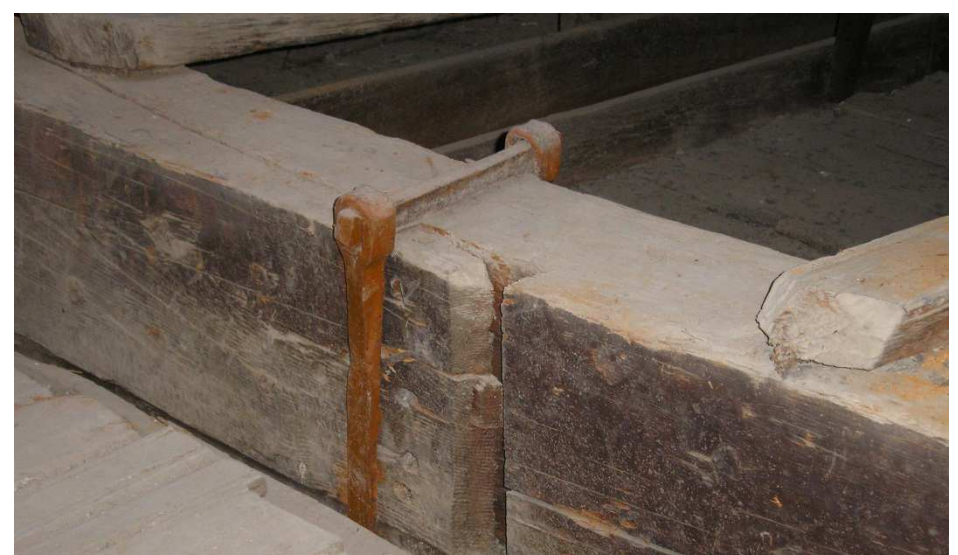
Connection of the truss tie - Jupiter dart
