Concrete and timber structures

Case studies

PIETRO CROCE

Assessment of existing structures

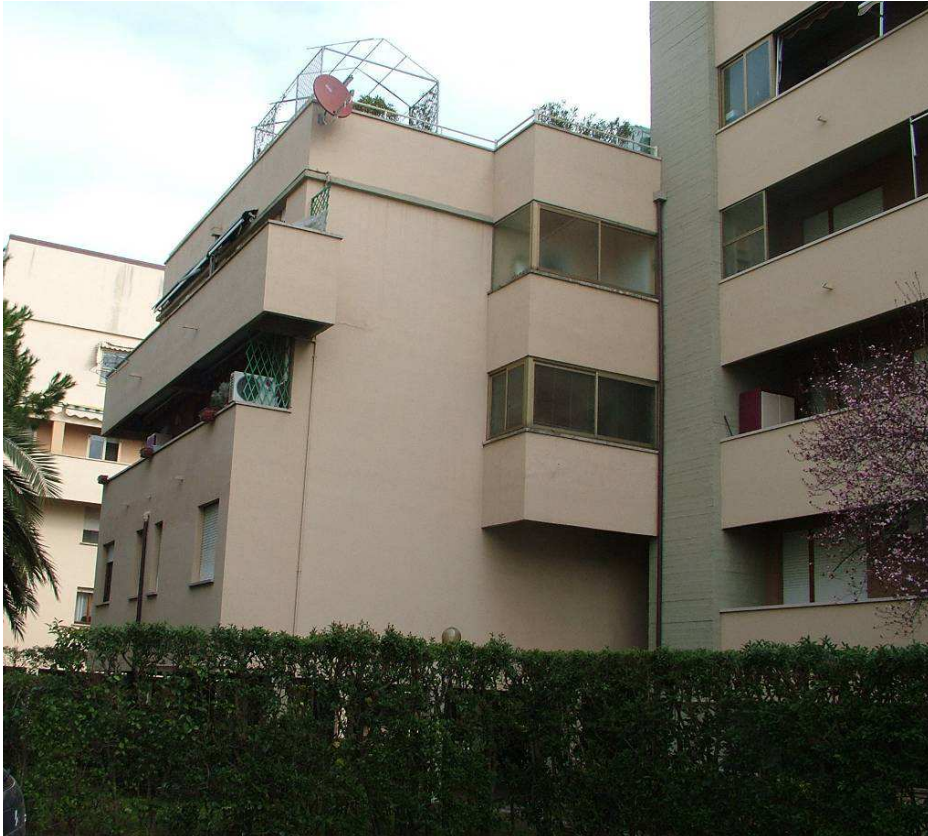
General view of the building

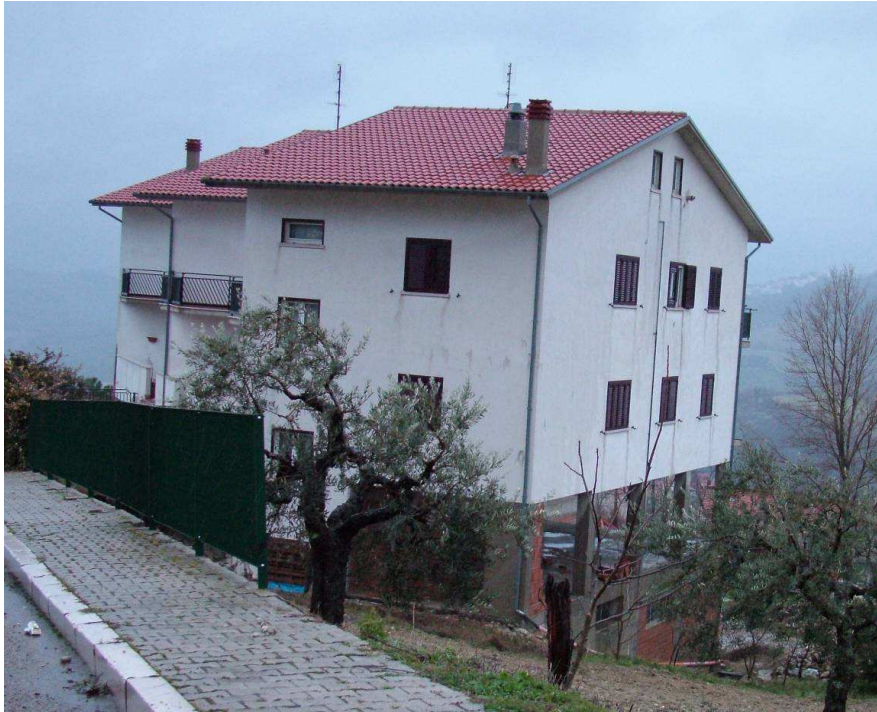
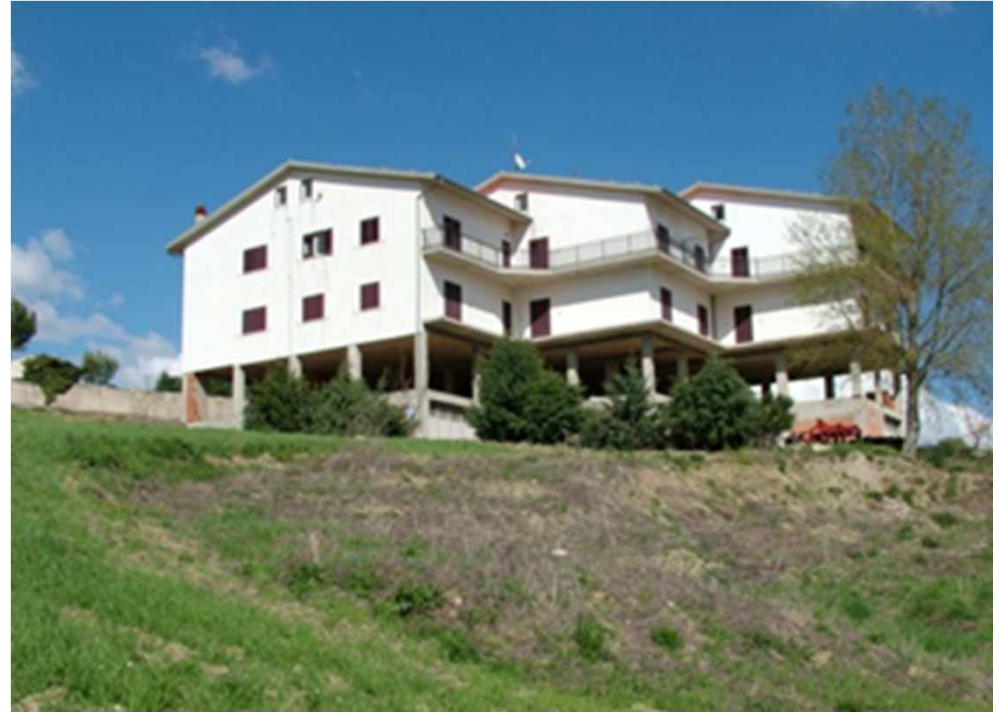
Views of the existing building

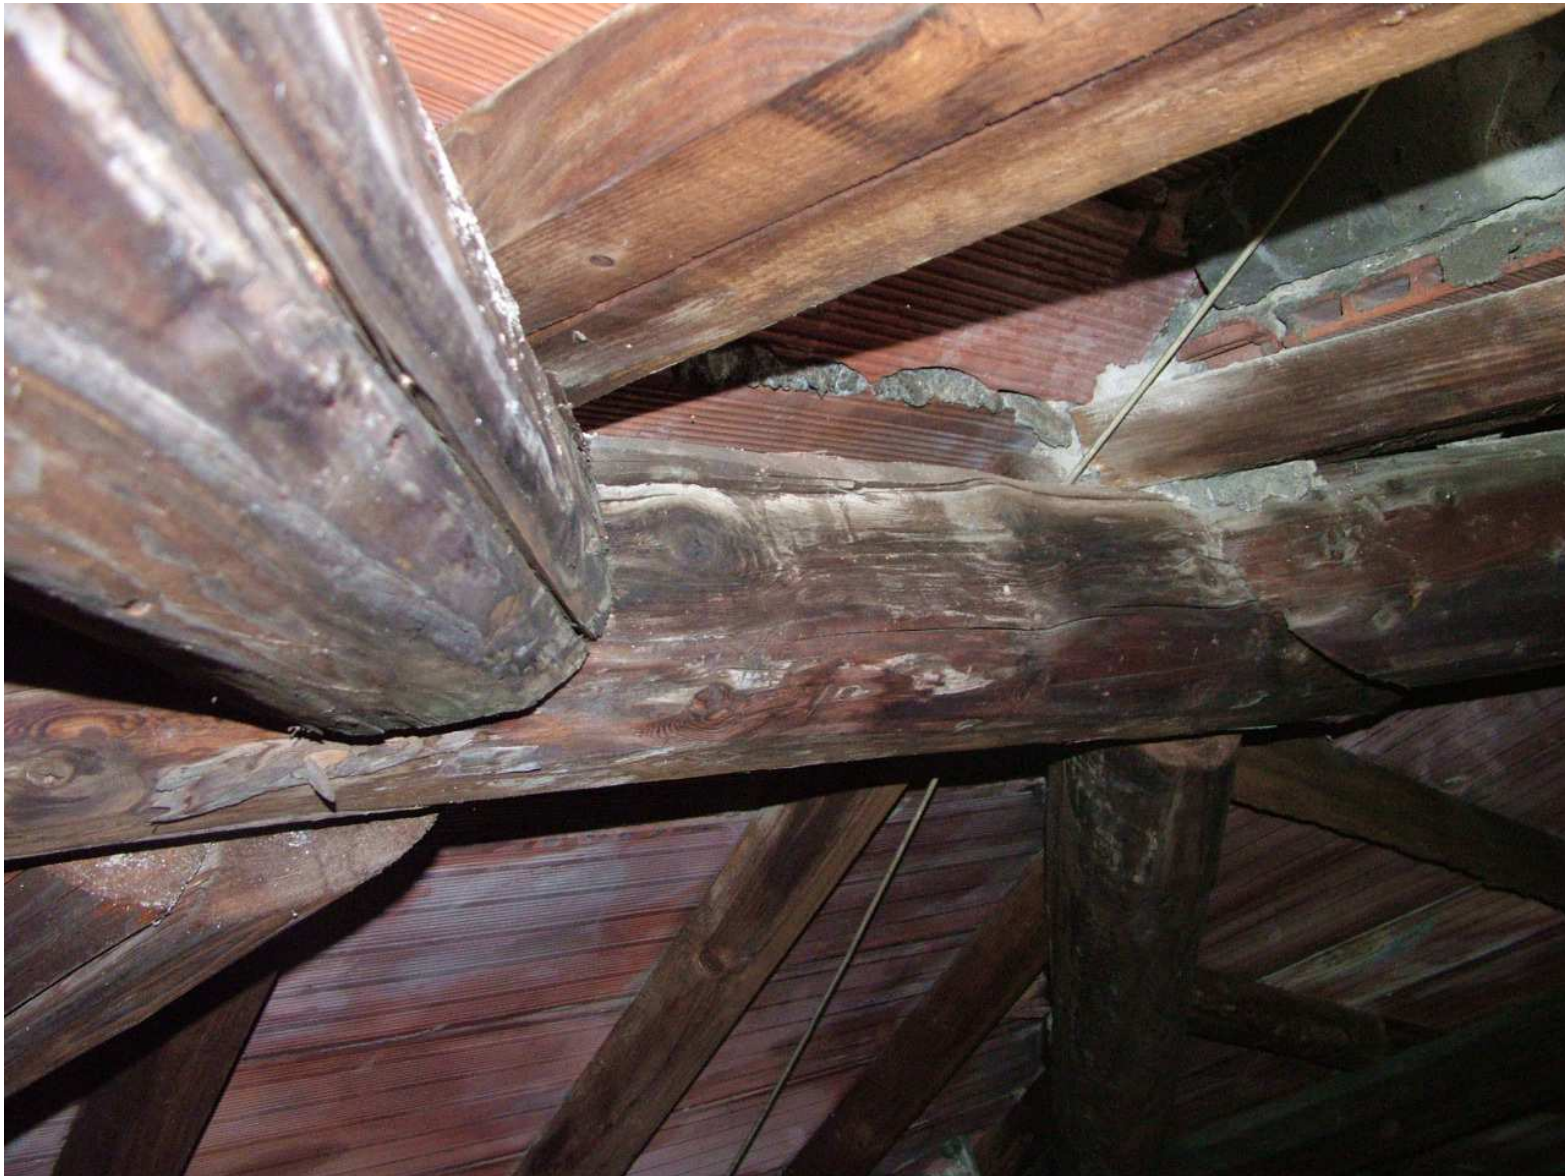
Connection between ridge beam and hip beams

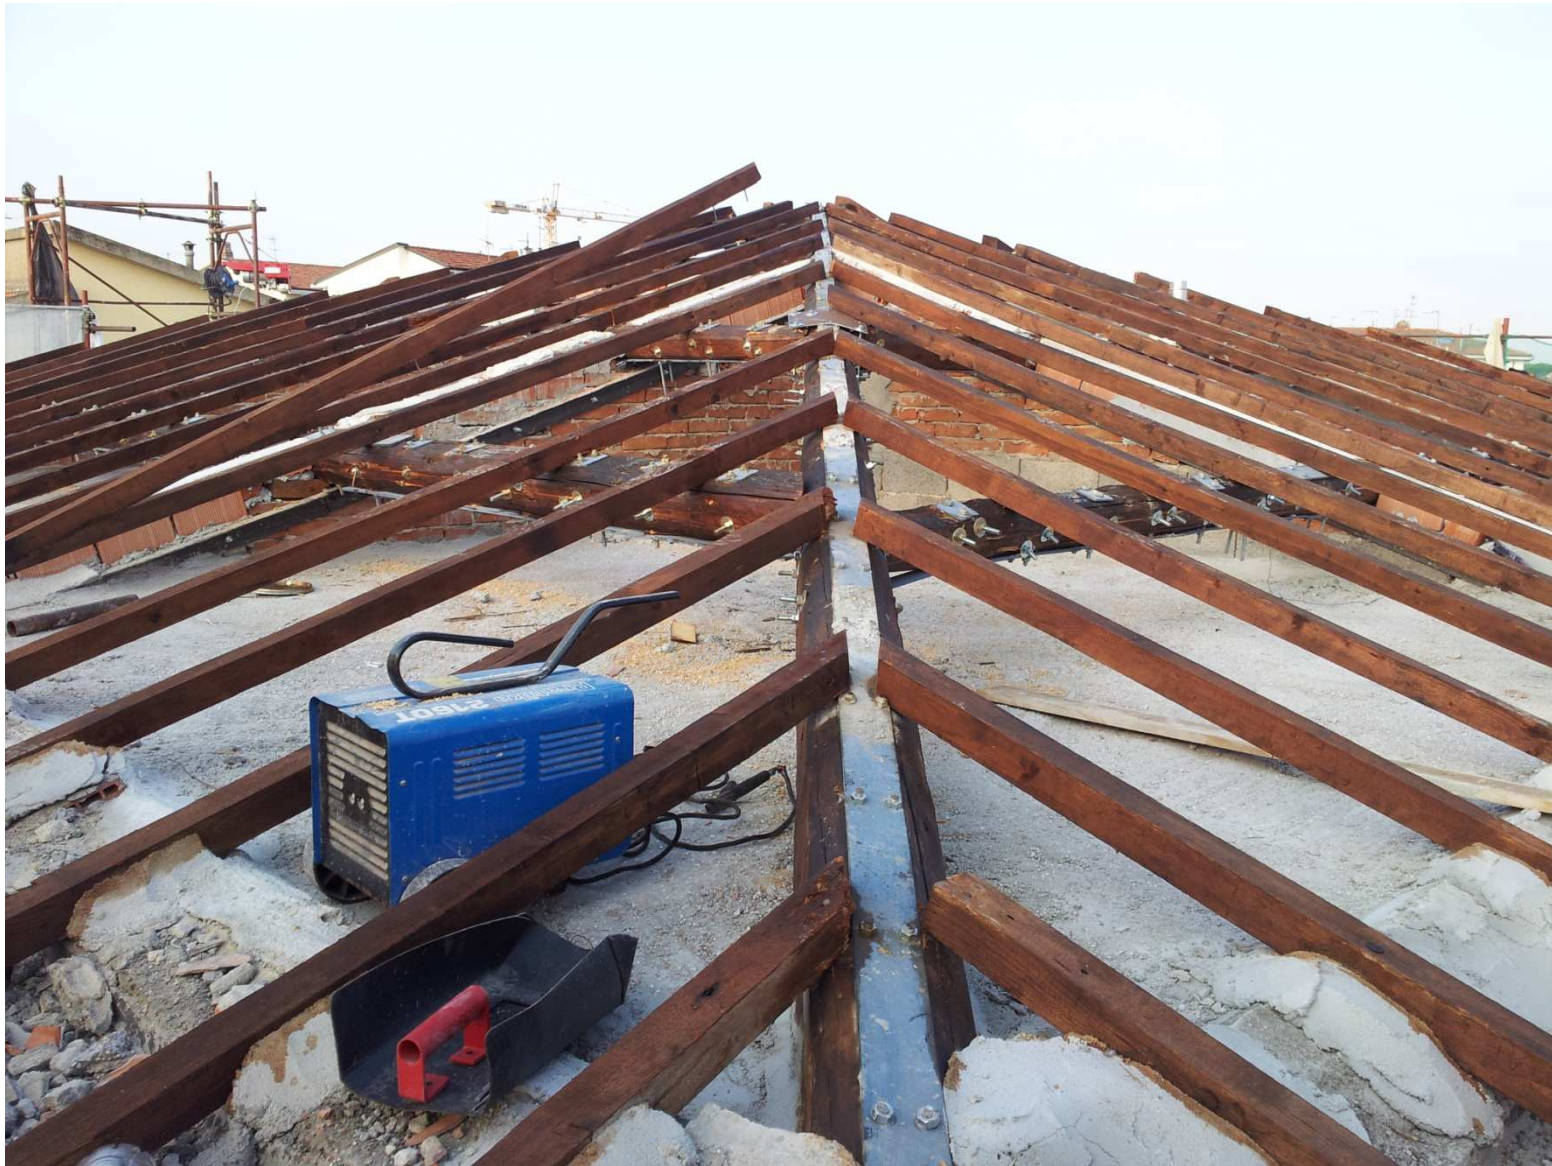
View of the roof during the work

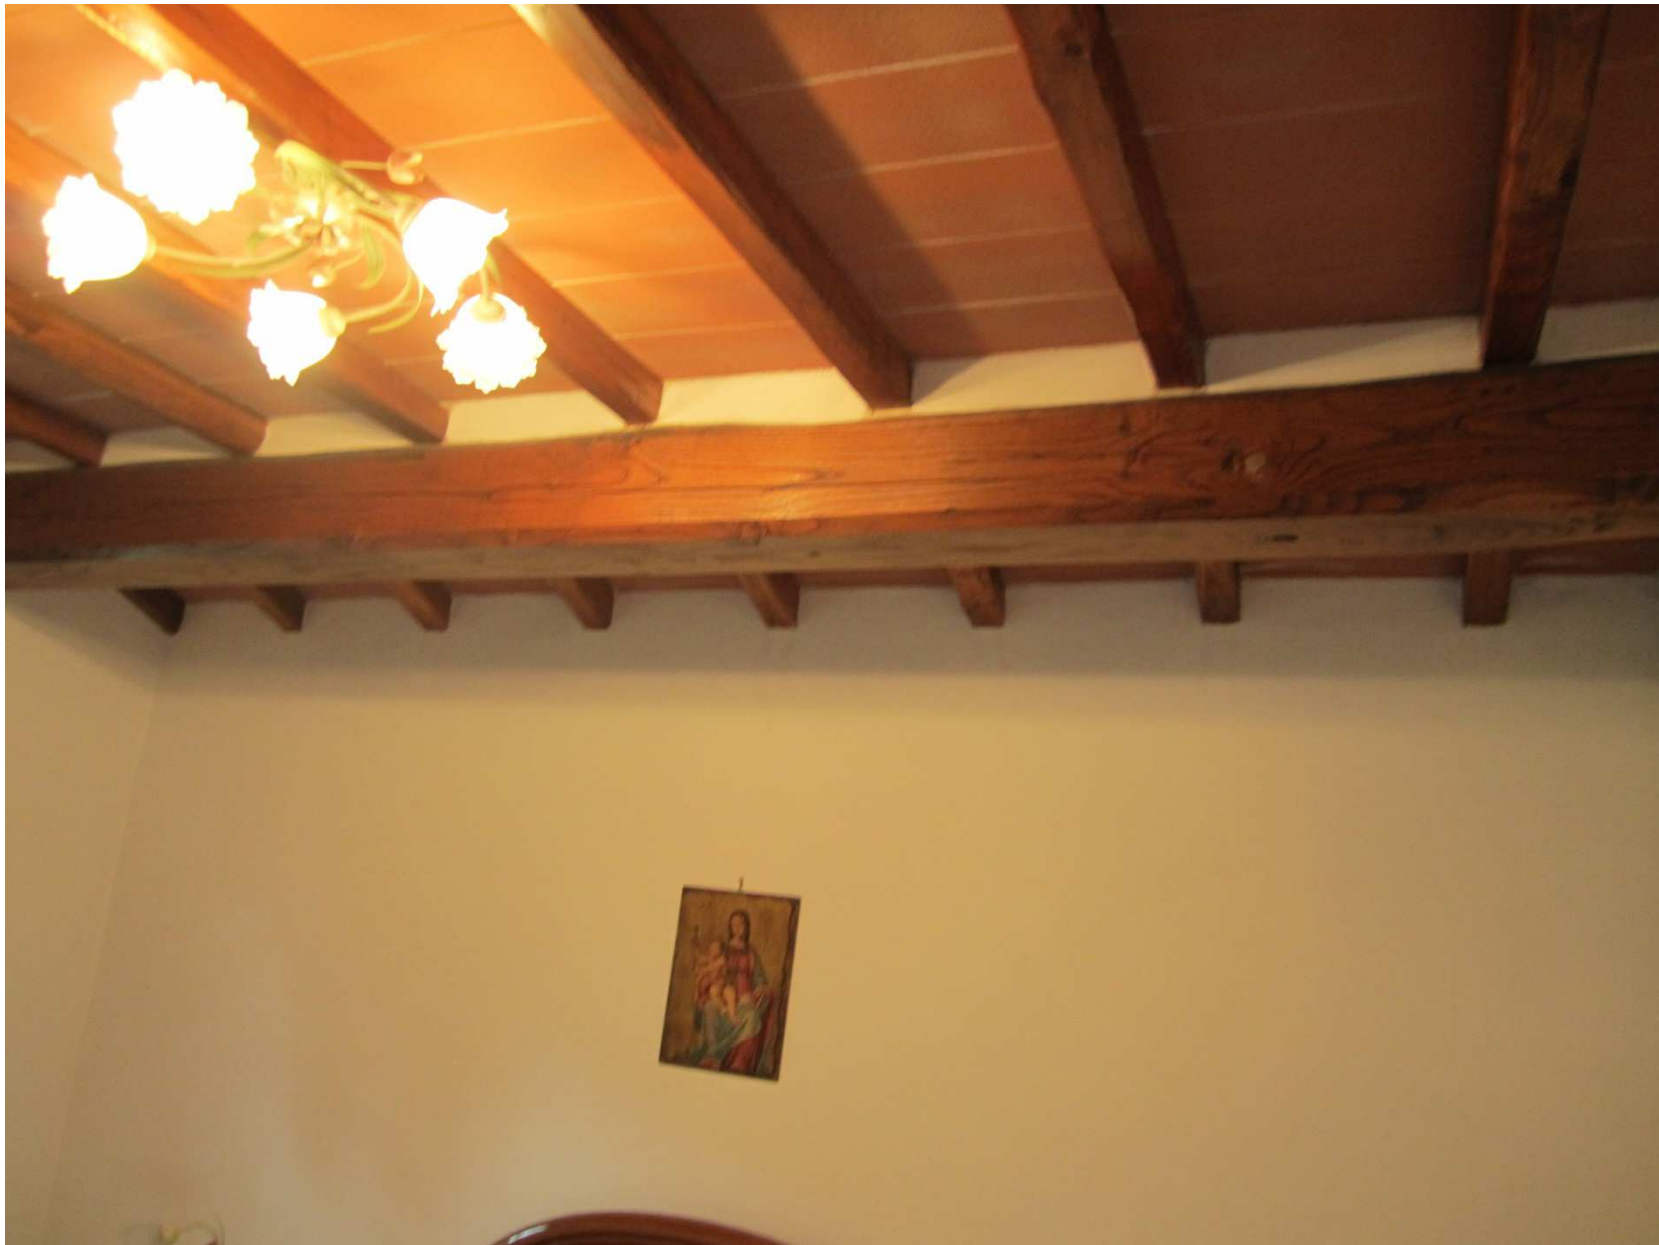
Insufficient cross section – Uncorrect wood fibre pattern

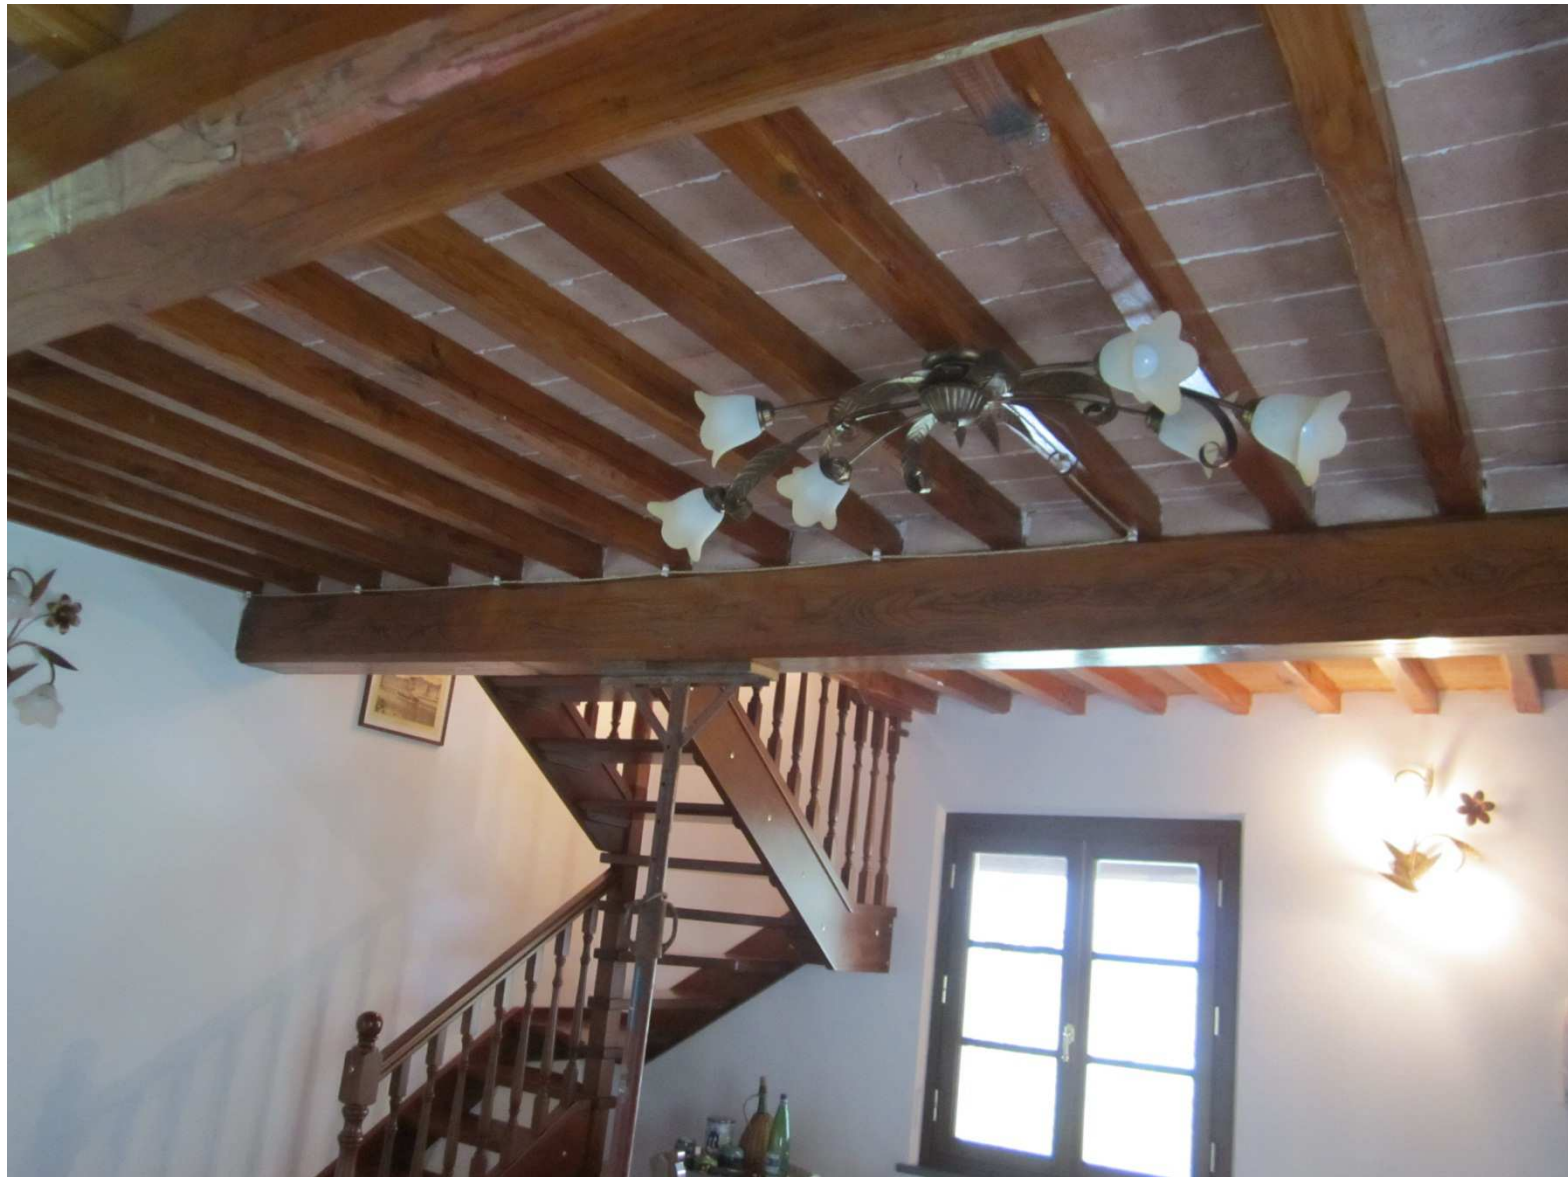
Beam supported with a pack prop

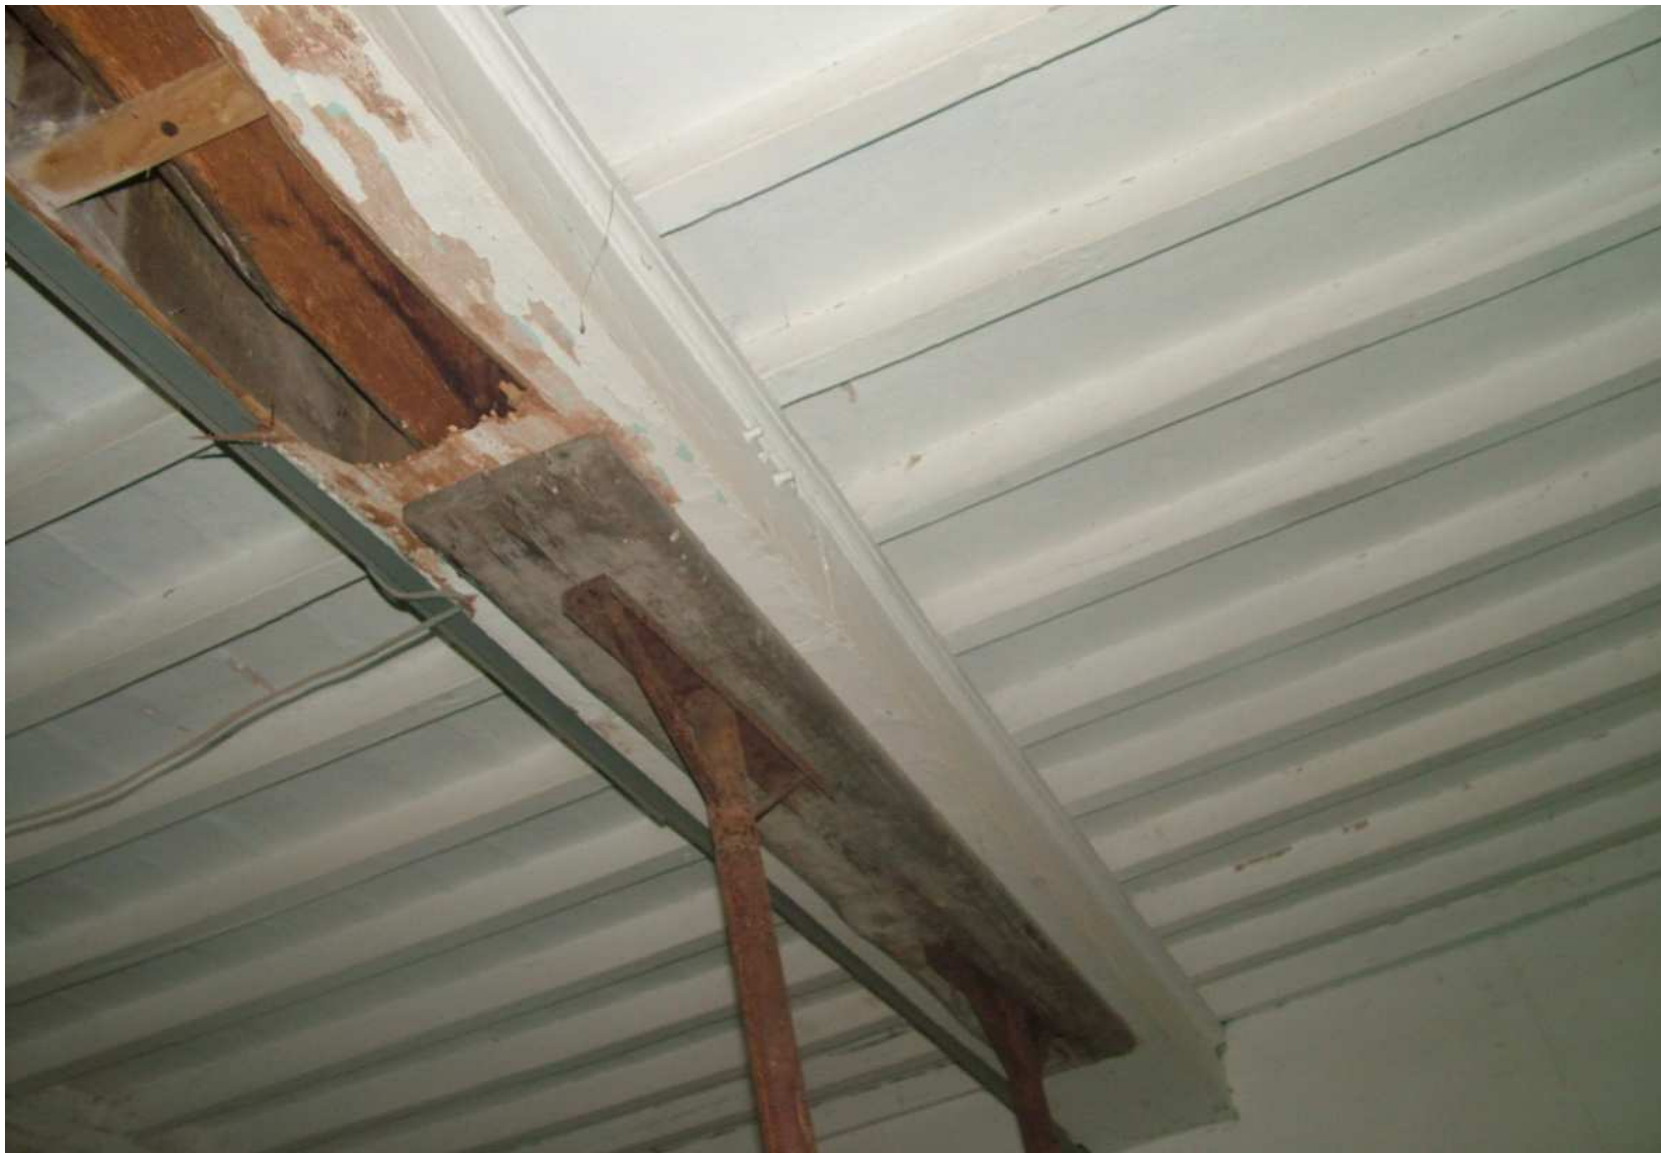
A surprising arrangement of the cover

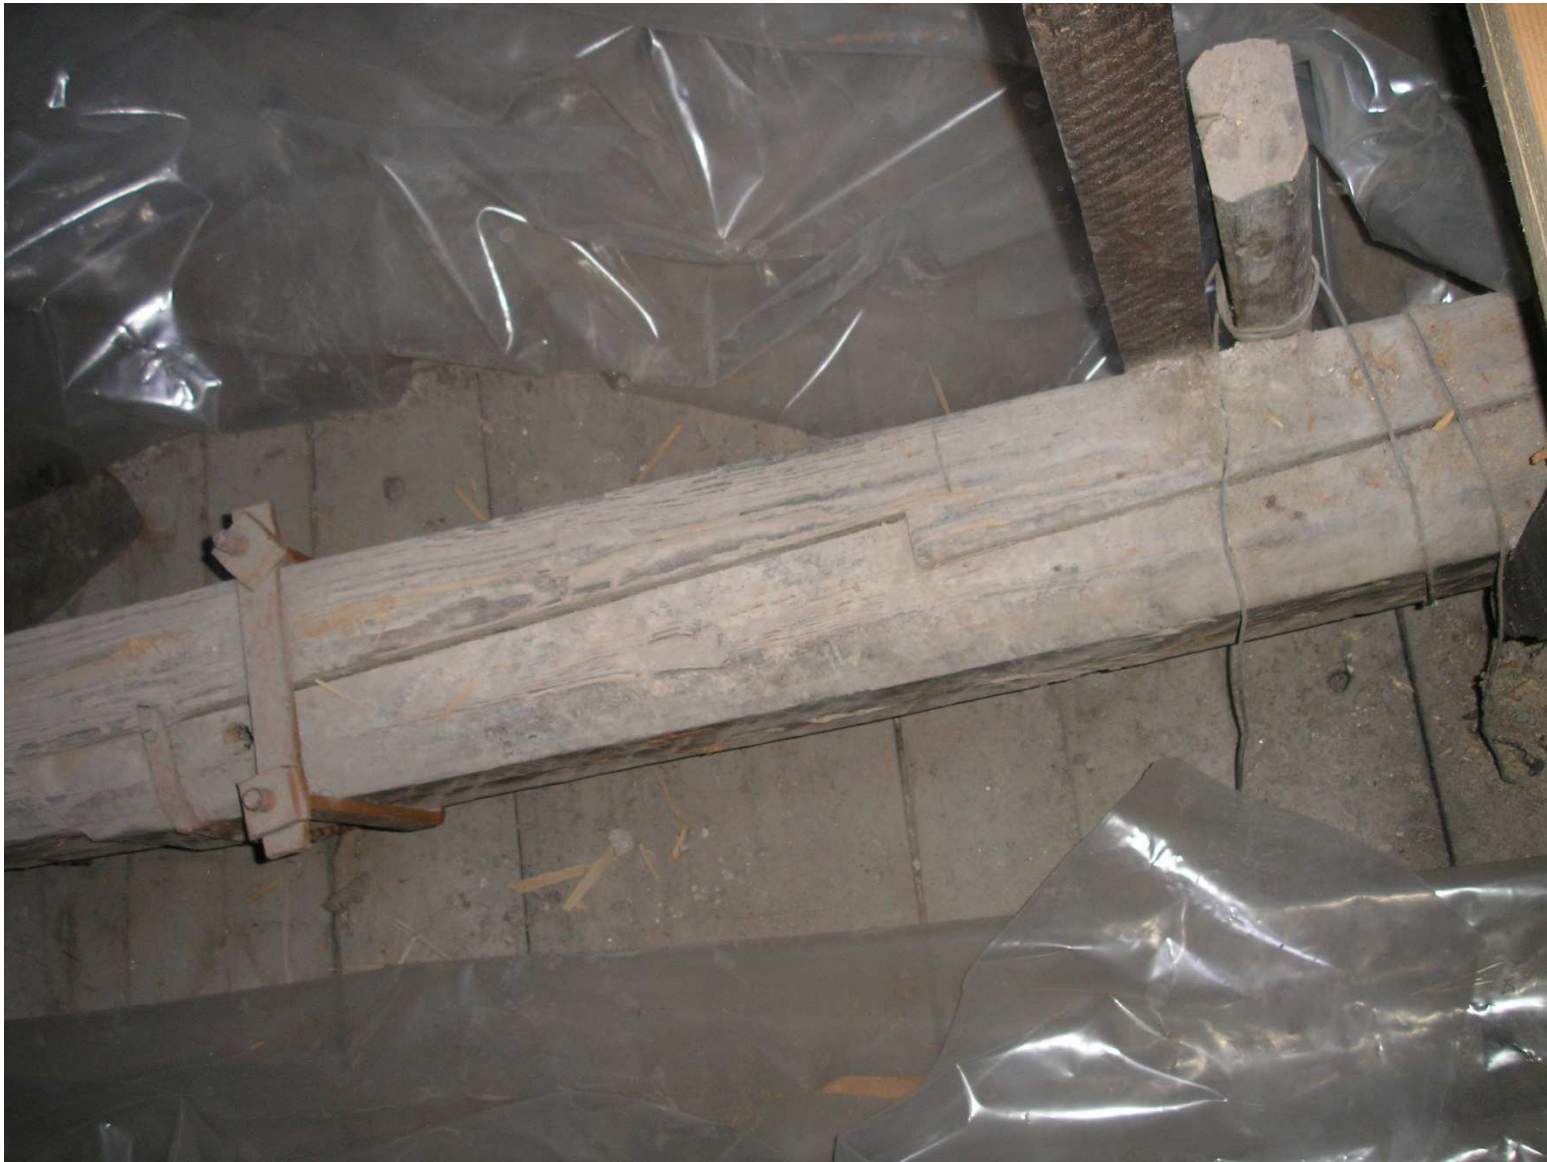
Connection of the truss tie - Jupiter dart

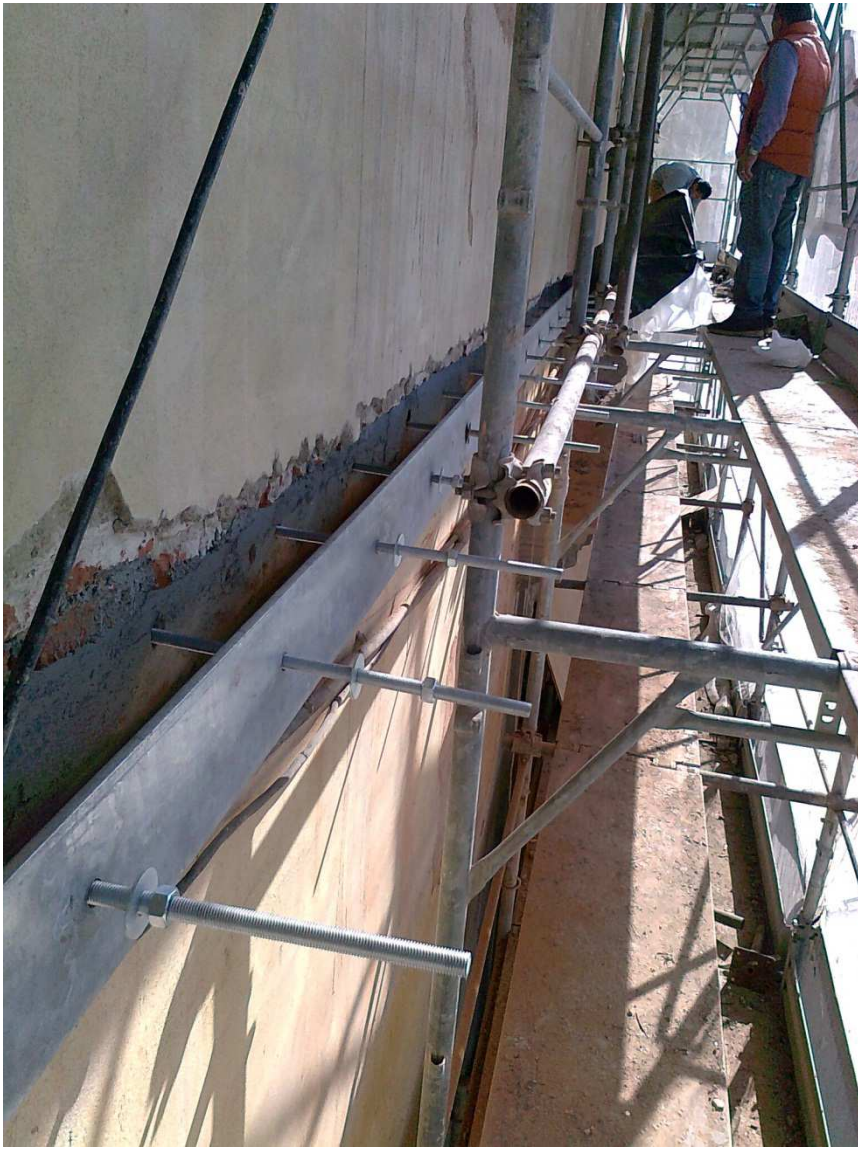
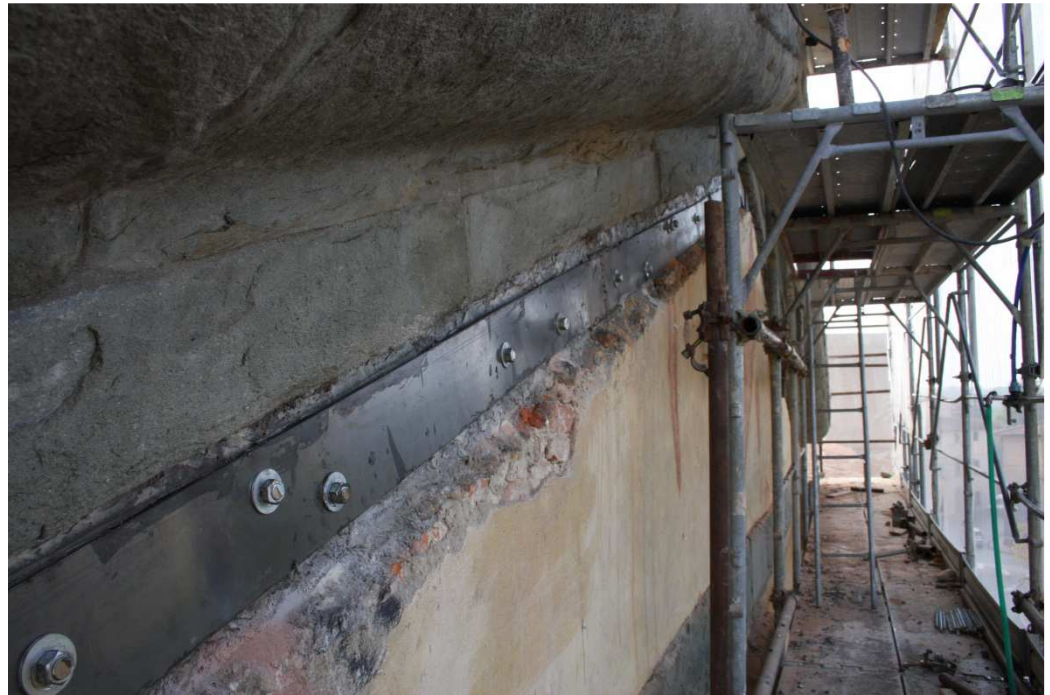
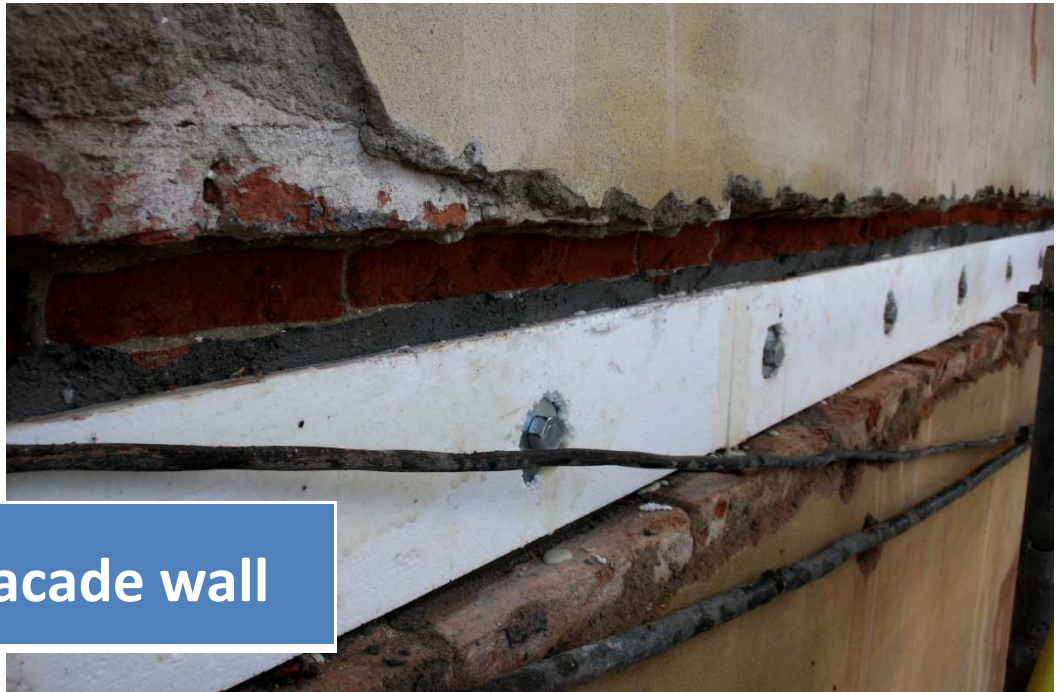
Strengthening of the facade wall
